PUBLIC WORKS COMMITTEE AGENDA

THOUGHTS FROM ADA WALKABOUT TOWN OF SHEPHERDSTOWN JEFFERSON COUNTY, WEST VIRGINIA

TECHNICAL ASSISTANCE REPORT

Group reporting on issues found by description, location, repair criticality, and photos. Information on each location is included in this presentation.

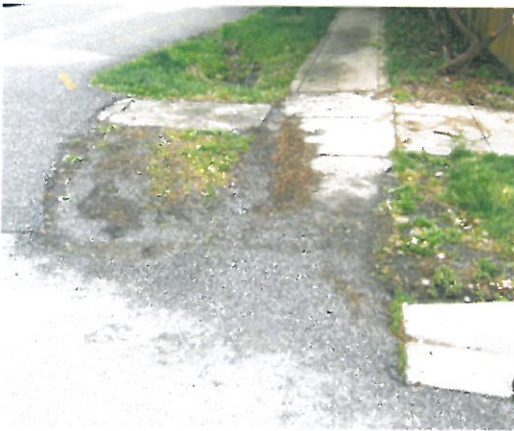
Sidewalk to street transitions on northwest corner of E. High and N. Mill Street are shown here. The transitions lack detectable warning surfaces and the sediment accumulated at the end of the sidewalk along High makes the transition impassible. The new curb recently installed along Mill Street could be considered to an alteration to the street; therefore, the ramps along Mill should have been brought into compliance with current criteria.

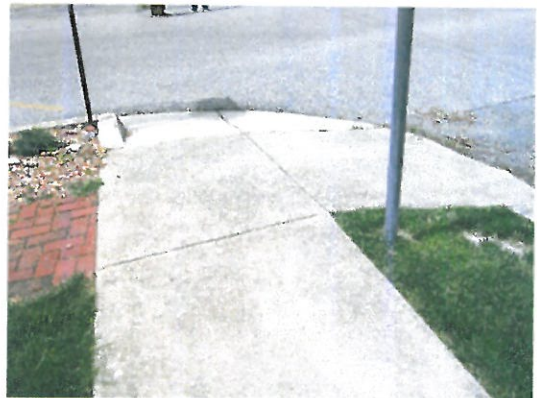
Sidewalk to street transitions on southeast corner of S. Church and W. New Streets are depicted here. The gradients are too steep. Since the curb is missing around the entire corner, detectable warning surfaces are needed around the entire corner to advise visually impaired pedestrians that they are about to enter the street.

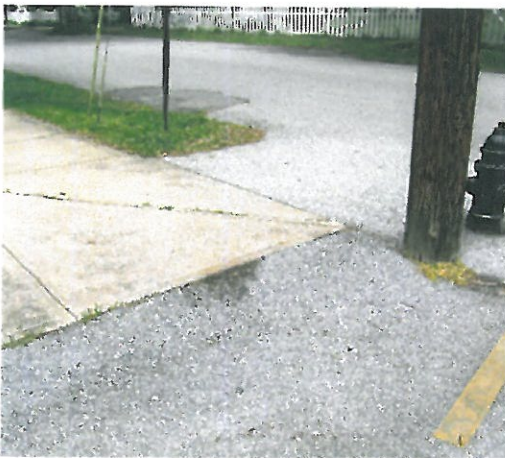
Sidewalk to street transitions on southwest corner of S. Church and W. New Streets can be seen here. The gradients are too steep and the grade breaks too sharp. There are no detectable warnings where the ramped surface meets the street.

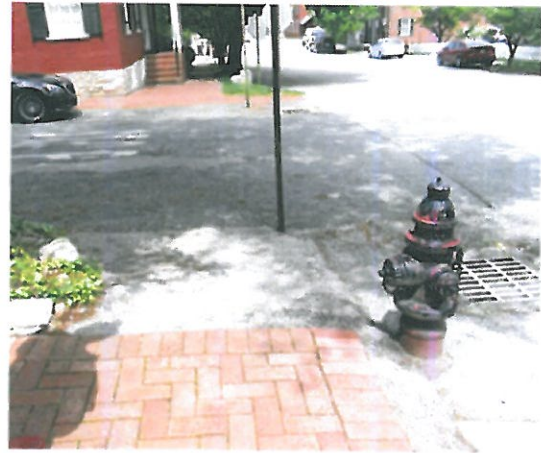
Sidewalk to street transitions on southwest corner of E. New and S. King Streets are shown here. There are concerns with ramp gradients and surface condition, including a drainage grate with large (non-compliant openings) in the path of travel. Wheels of a manual wheelchair or a walker could easily drop into the openings. Since the curb is missing, detectable warnings are needed at the bases of the ramped surfaces.

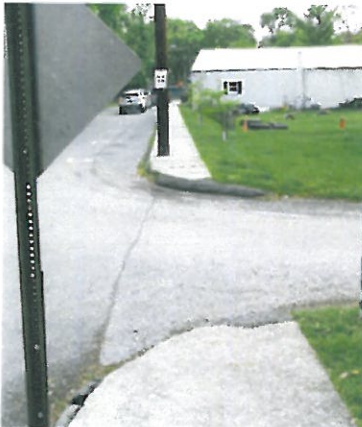
As shown, there are no curb ramps at intersection of W. High Street and N. Maiden Lane. The lack of ramps here is a concern given that Bane Harris Community Park (a destination) is adjacent to this corner. Parks should be accessible to all.

It is suggested that the Town perform a self-evaluation of all of its corners with sidewalks to identify locations where curb ramps exist (and determine whether the sidewalk to street connection is in compliance with current PROWAG criteria) and to identify corners without curb ramps. Then a prioritized list of curb ramps to be installed and retrofitted should be developed along with a schedule of when these barriers will be removed.

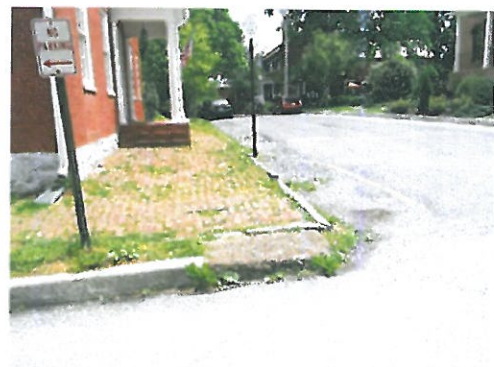
No curb ramps at northeast corner of S. Church and W. New Streets.

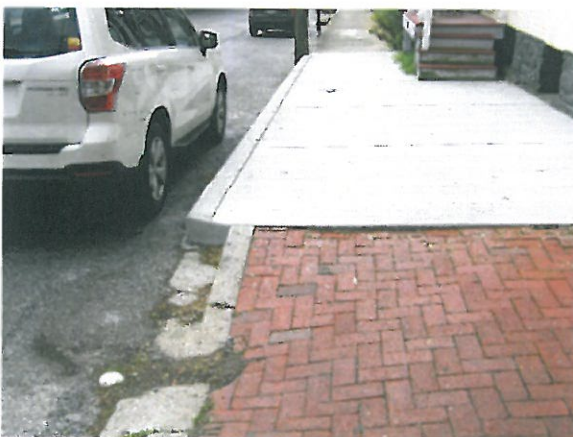
A significant number of changes in level, like that shown here, were observed in walkway surfaces. Such elevation differences often occur at joints in the sidewalk or, as depicted here, at the intersection of different surface types.

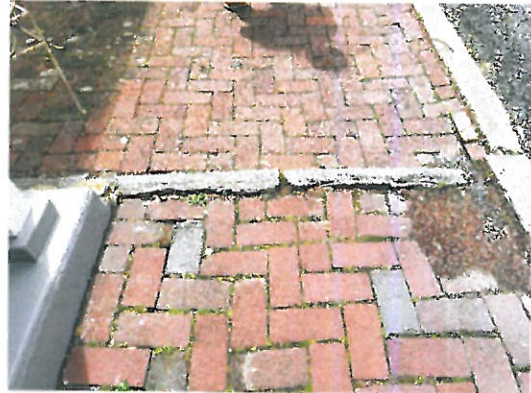
At a number of locations, limestone “inserts” were noted in brick sidewalks. The purpose of these features is not known. Nor is it known if they represent historical artifacts. In many instances, as shown here, the height of the “insert” exceeded ¼-inch vertical, creating an accessibility barrier for the mobility impaired and could facilitate trips and falls for all pedestrians,

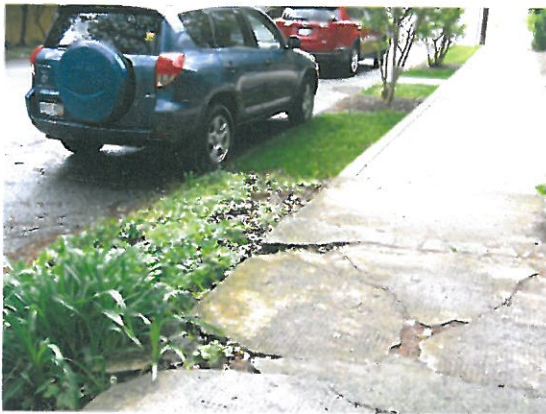
E. High Street

Depending on the magnitude of the irregularity, deteriorated surface condition can create a barrier to accessibility and/or a safety concern. A large number of locations, both on concrete sidewalks and brick sidewalks, were observed where surface discontinuities existed. Two representative locations are depicted here

As part of the aforementioned self-evaluation, it is suggested that the Town identify the locations of surface discontinuities, both changes in level and deteriorated surface condition, which represent barriers to mobility. Then a prioritized list of the locations needing barrier removal along with the modifications necessary should be developed including a schedule of when the barriers will be removed.

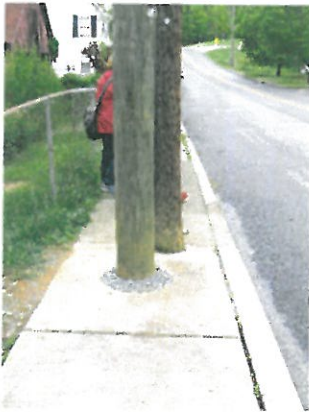
At a number of locations, there were utility poles in the middle of the sidewalk. In some cases, as shown here on E. German Street, there were “double” poles with the poles not lined up with each other, thus blocking more of the sidewalk. This is an inaccessible sidewalk.

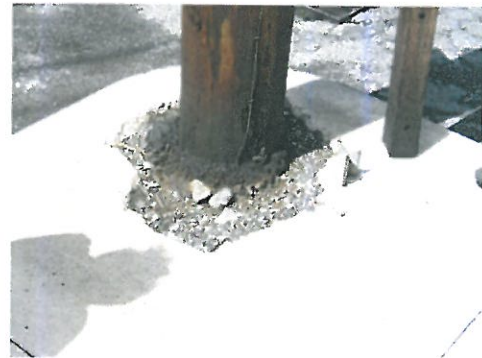
At some locations, such as shown here in the northeast corner of E. Washington Street and South Princess Street, the area of concrete that had been removed was significantly larger than the pole itself, reducing the width of the pedestrian access route even more. This situation should be communicated to the utility responsible for the pole.

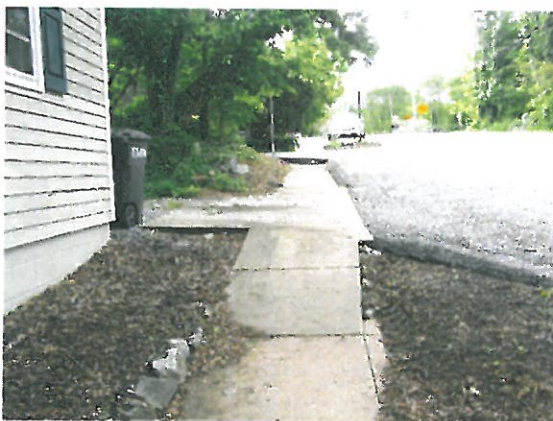
Under PROWAG, a sidewalk adjacent to a street can be the same grade as the street, regardless of steepness. Sidewalk gradients steeper than the street grade are not permitted. A short section of

sidewalk on the north side of E. High Street was observed to have a grade steeper than the street grade. The grade and grade break present an obstacle for those with mobility impairments.

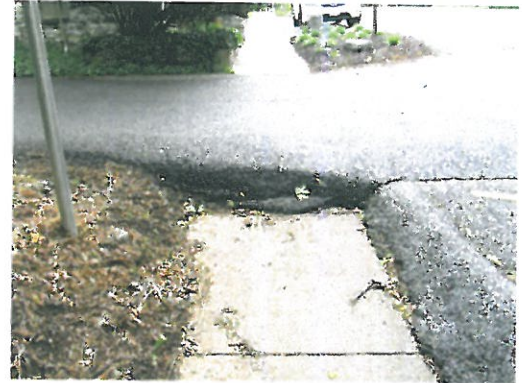
Also on High Street, at Rocky, was a vertical elevation difference due to multiple street resurfacings. This elevation difference is a significant obstacle for individuals with mobility impairments,

As part of the aforementioned self-evaluation, it is suggested that the Town identify the locations of obstacles in the sidewalk, such as utility poles, steep grades and large vertical elevation differences, which represent barriers to mobility. Then a prioritized list of the locations needing barrier removal along with the modifications necessary should be developed including a schedule of when the barriers will be removed.

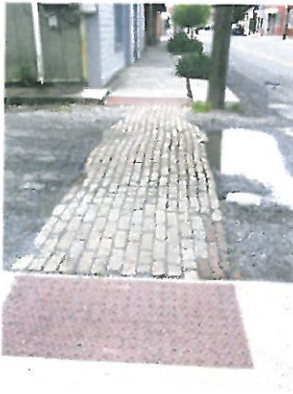
In other cases, the sidewalk ramped down flush with the alley, however, the alley surface was not accessible. The image shows the intersection of E. Back Alley with S. Princess Street. Note that while ramps and detectable warning surfaces are present, the surface of the crosswalk consists of bricks and is very rough with cross slopes (in both directions) steeper than 2 percent at some locations. This is not an accessible crosswalk.

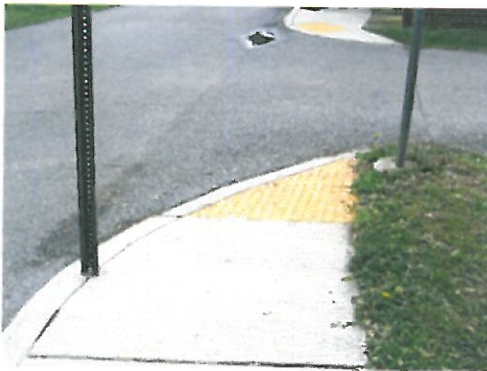
When detectable warning surfaces are installed, they need to comply with the PROWAG requirements. This means 24 inches (2 feet) of truncated domes in the path of pedestrian travel everywhere the curb is missing. The detectable warning surface shown at the directional curb ramp in the southwest corner of the intersection of W. High Street and Brown's Alley does not comply with the criteria.

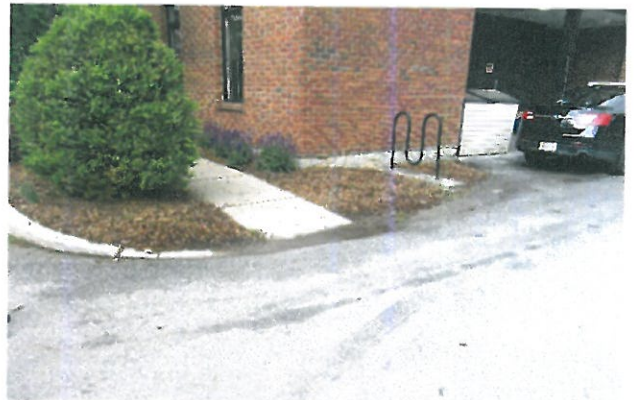
On the north side of Town Hall, where the sidewalk in front of Town Hall meets Old Queen Alley, the sidewalk is light gray concrete. As shown in the photograph, the detectable warning surface is also white/light gray in color. Thus, the required contrast between the detectable warning surface and the background is not present, making it difficult for a low-vision pedestrian to detect the warning surface. The detectable warning surface needs to be a contrasting color such as yellow or brick red.

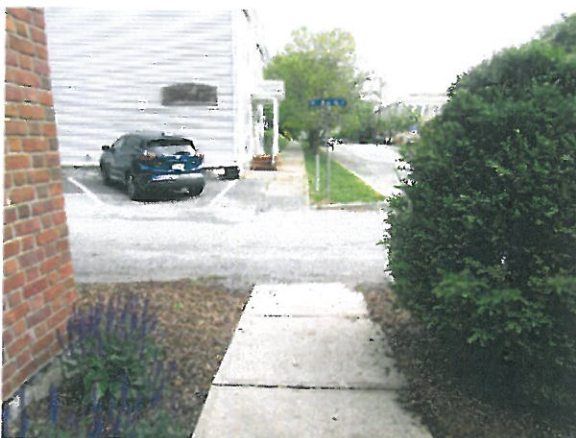
As shown here, while there is a detectable warning surface on the Town Hall side of Old Queen Alley, there is no corresponding surface on the opposite side of the Alley. For consistency in terms of the warning function, detectable warning surfaces are needed on both sides of the Alley.

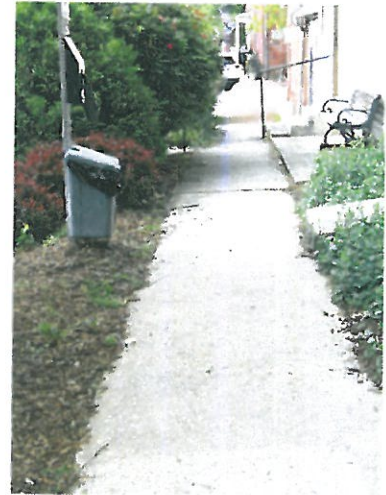
The photograph shows the sidewalk in the area of Town Hall. The sidewalk itself has adequate width. However, notice in the background that shrubs overhang the sidewalk. These create a protruding object hazard for visually impaired pedestrians since the vegetation cannot be detected with a long cane. Beyond the shrubs, ground-type vegetation in the form of lilies, extends a significant distance over the sidewalk. Both the shrubs and the ground cover vegetation reduce the effective width of the sidewalk to less than the required 4 feet for all pedestrians. Property owners should be required to trim/prune vegetation as needed to maintain an accessible sidewalk width, without protruding objects.

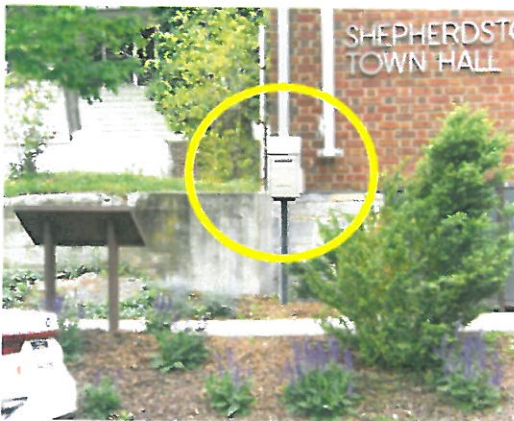
As shown here, there is a drop box located in front of Town Hall. However, the drop box is set back from the sidewalk and is too high to be accessible to an individual in a wheelchair. The box should be lowered and located immediately adjacent to a hard surface.

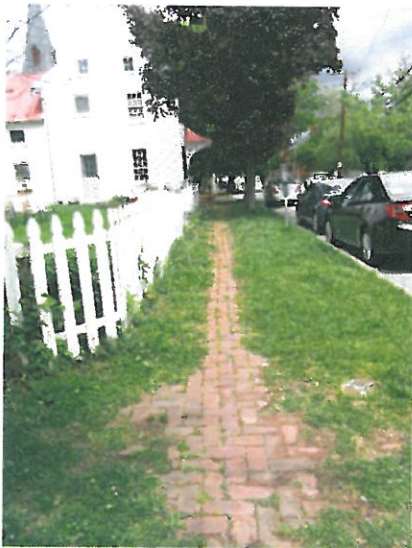
While the use of brick for sidewalks is attractive and relates to the history of the Town, to keep a brick sidewalk in accessible condition, like the one shown here on W. German Street, requires considerable maintenance. A brick surface (or even a stamped concrete surface) creates vibration for people in manual wheelchairs which can be excruciatingly painful to individuals with certain types of spinal cord injuries. Thus, the best practice is to make travel surfaces smooth concrete and place any color or texture in border areas.

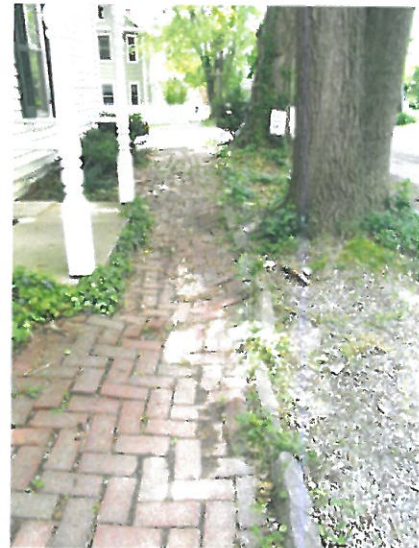
Sidewalk sections that have become inaccessible due to lack of maintenance.

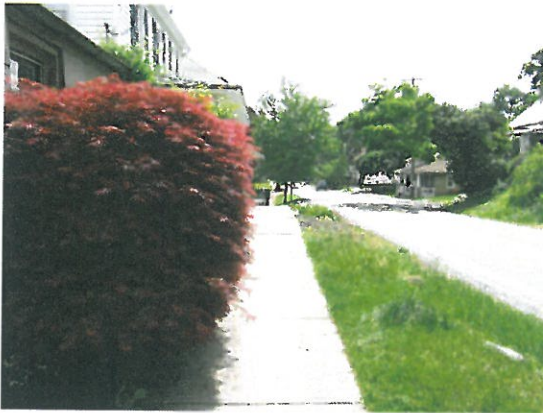
While individual preferences allow property owners to personalize their sidewalks, the lack of a consistent surface along a block or street can create issues such as shown on page 4, where vertical changes in level are created at property lines. A policy calling for a consistent surface type when a sidewalk is reconstructed would minimize such occurrences.

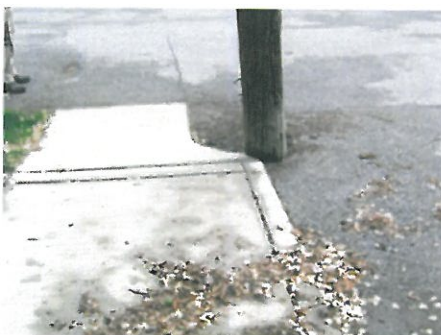
It appeared that sidewalks along N. Mill Street and E. High Street had recently been reconstructed. A section of the sidewalk along N. Mill St. is shown here. However, where the new sidewalk sections intersect in the southwest corner of the intersection, no detectable warnings were installed on N. Mill or on E. High. This corner should be high priority in terms of detectable warning installation. In addition, the requirement for detectable warning surface installation at curb ramps should be part of the sidewalk reconstruction specifications provide to property owners.

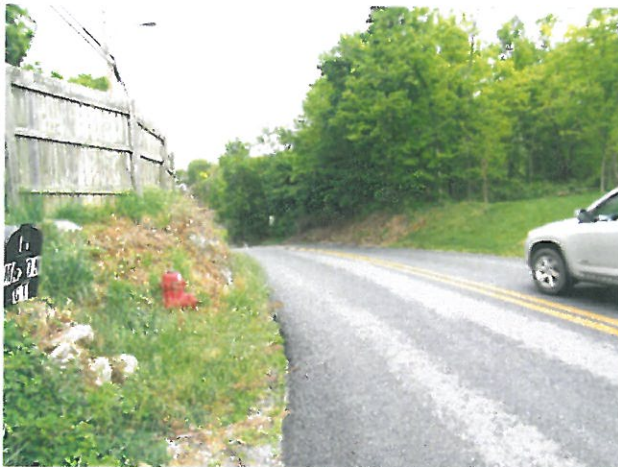
Given the current lack of a sidewalk on the south side of E. German Street, Sage Place residents must cross E. German to access the sidewalk on the north side. However, at this location, there is a sharp crest curve in the alignment of E. German (partially shown here) which prevents pedestrians from seeing oncoming westbound vehicles and prevents westbound drivers from seeing crossing pedestrians, creating serious safety concerns. Design of a sidewalk along the south side of E. German from Sage Place to the Christ Reformed Church should be explored.

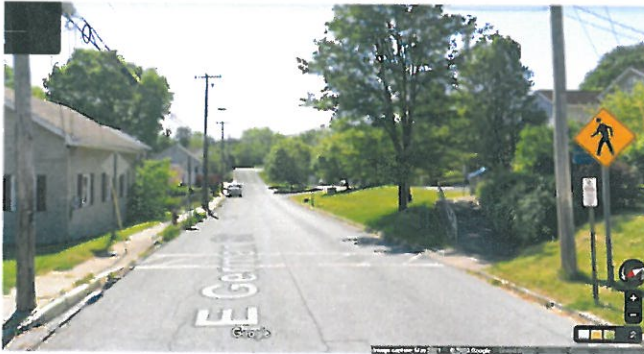
As can be seen in the May 2021 Google image, at that time, there was a marked crosswalk on E. German and curb cuts on both the south and north sides of the street. Both ramps lacked detectable warning surfaces and the ramp on the north side was inaccessible due to the presence of a guy wire for the utility pole on the corner.

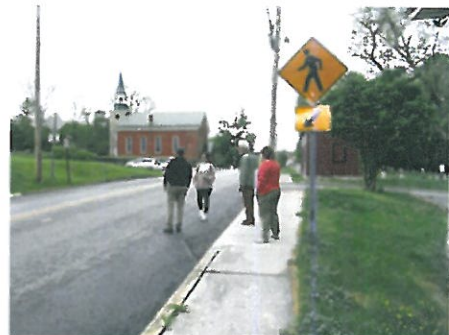
However, the resurfacing resulted in the ramp on the north side of E. German being removed. In addition, the crosswalk striping was not renewed. Note that, as shown here, the signing of this location (pedestrian warning sign with a downward arrow) indicates that this is a crosswalk. The arrangement is confusing and raises liability concerns. The situation should be discussed with the WVDOH. If nothing else, it appears that the downward arrow plaque should be removed.

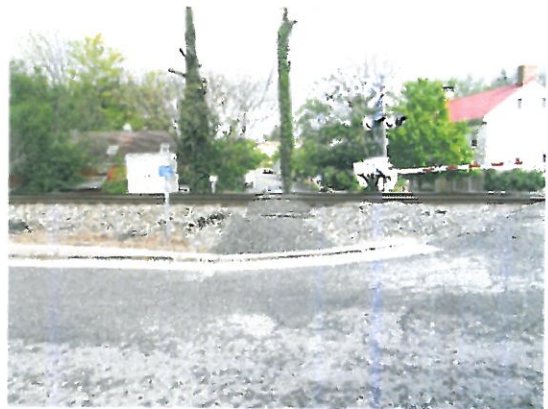
On the west side of the crossing, the roadway and south sidewalk grade are very steep, making a difficult traversal for all pedestrians but especially difficult for individuals with mobility impairments. Furthermore, due to periodic track raises by the Railroad, the walking surface at the tracks is humped and irregular.

Although the grades are more favorable on the east side of the crossing and south side of E. German Street, there are still surface condition issues attributable to the track raises.

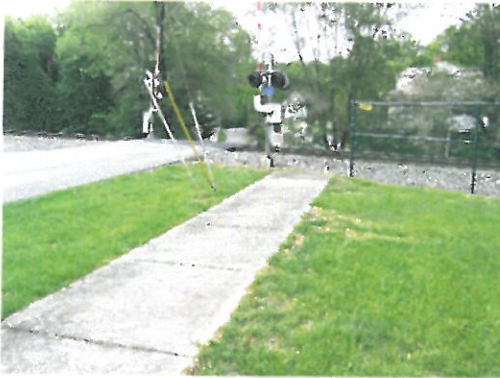
As shown here, due to the gradients involved, the crossing condition is no better on the north side of E. German Street. While not desirable from a safety standpoint, the best route over the crossing for an individual in a wheelchair would be to use the street.

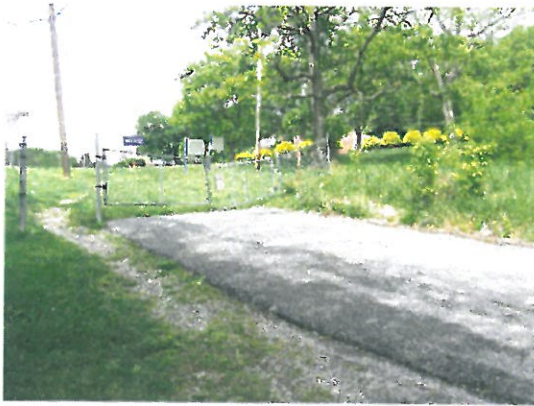
As illustrated here, while the street is gated, there is an opening in the fence which allows pedestrian access. Based on the “goat path” visible in the grass, it appears that this route is regularly used by pedestrians. Thus, it would be desirable to create a formal connection to University Drive.

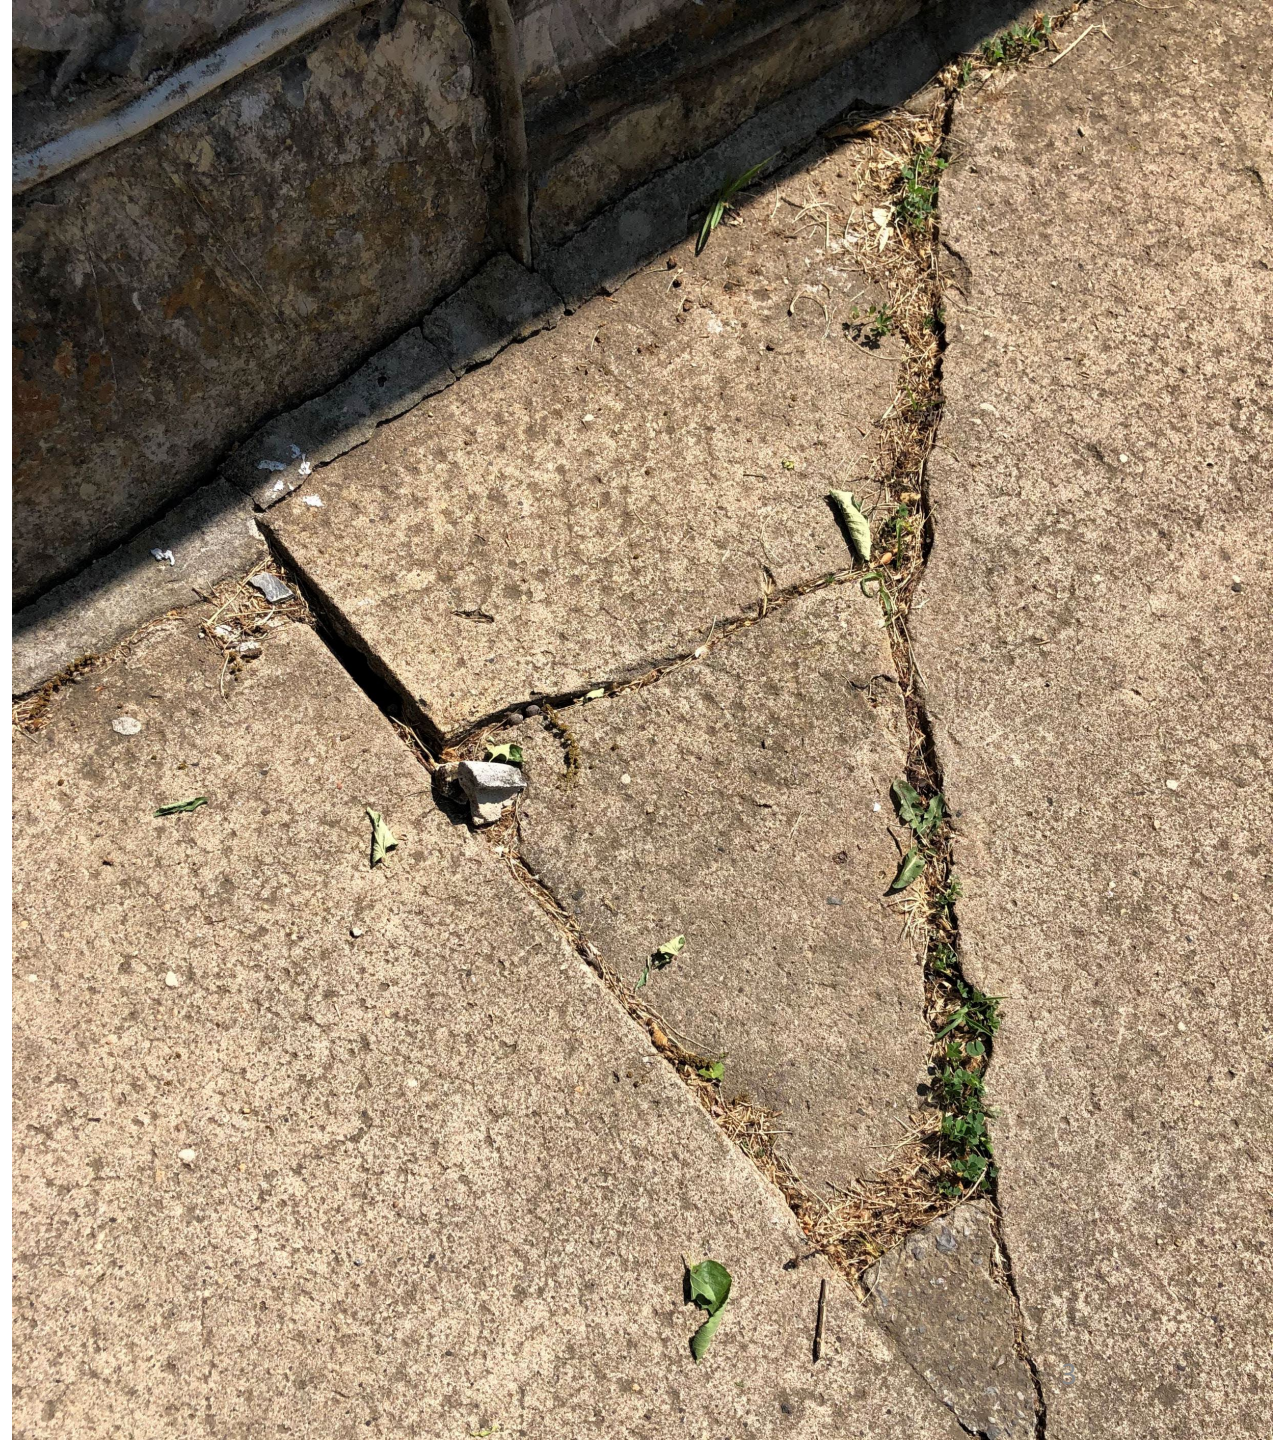
- Along the walkway overlooking the river
- Broken sidewalk is a tripping hazard
- Many cracks and gaps in this sidewalk
- Repair criticality: Moderate

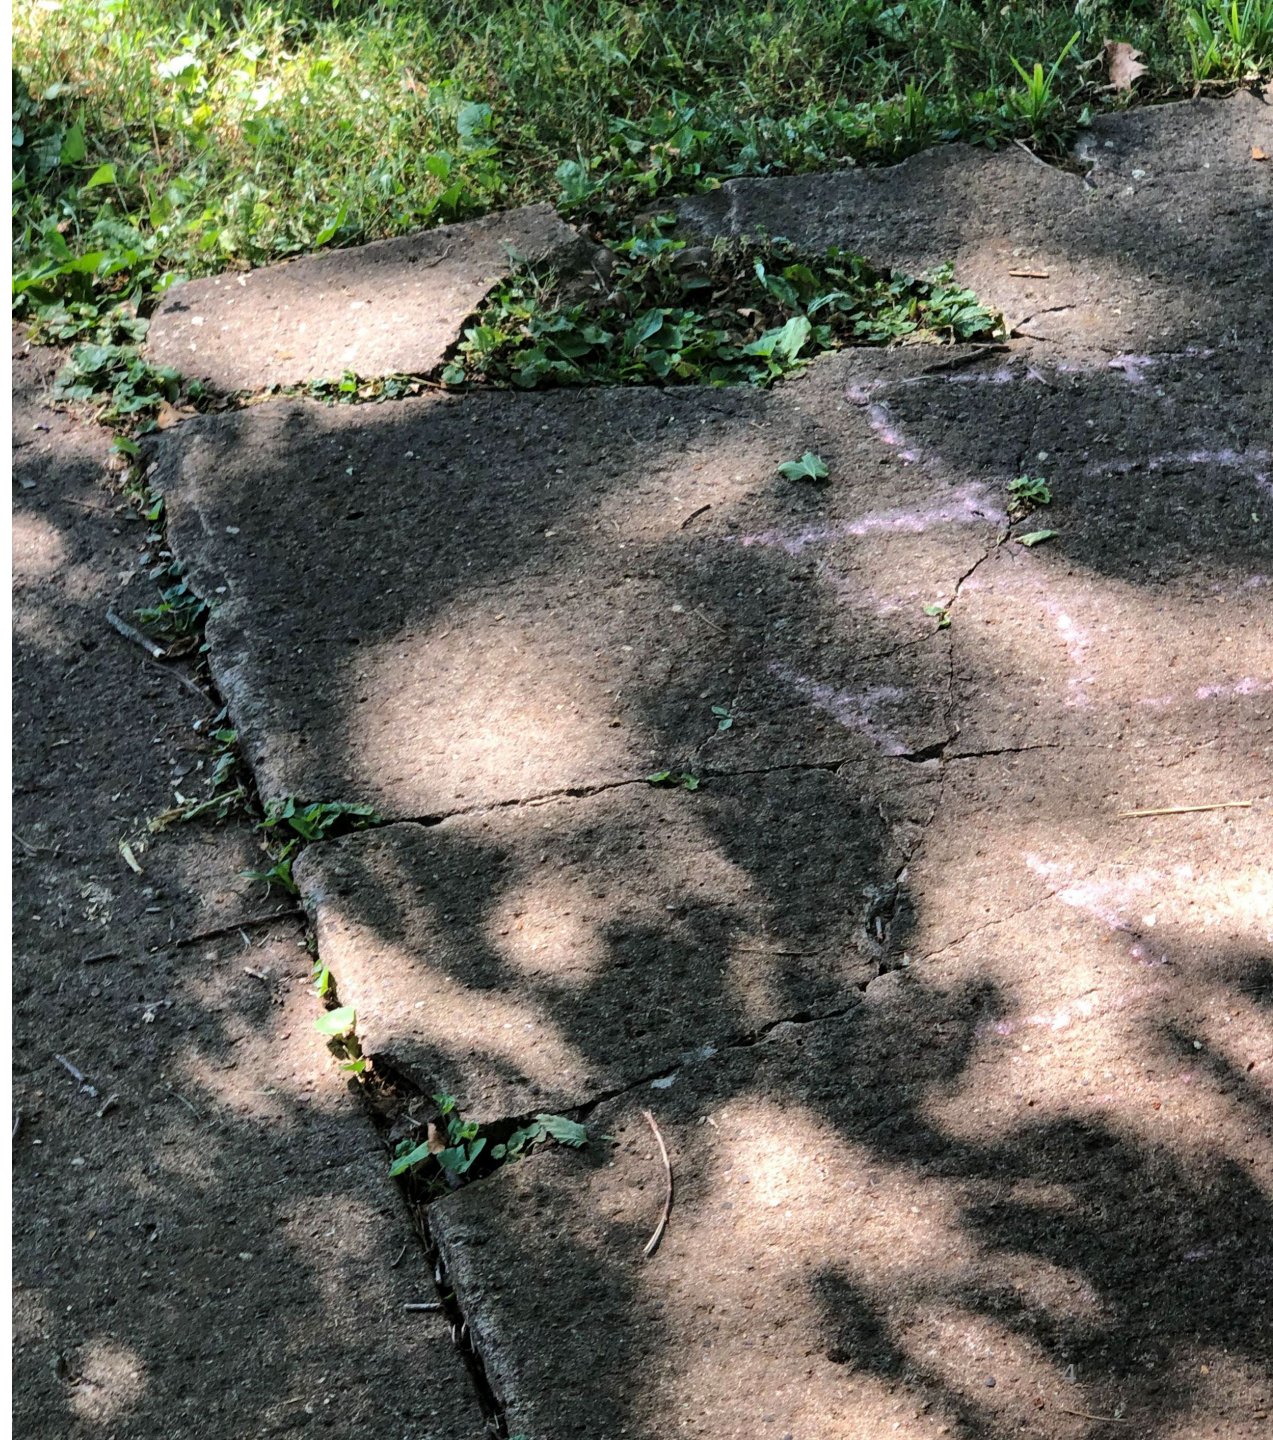
Rumsey Park

- Along the west side near Ethan Fisher's bench
- Broken platform
- This photo represents the condition of the sidewalks and platforms around the park
- Repair criticality: Moderate

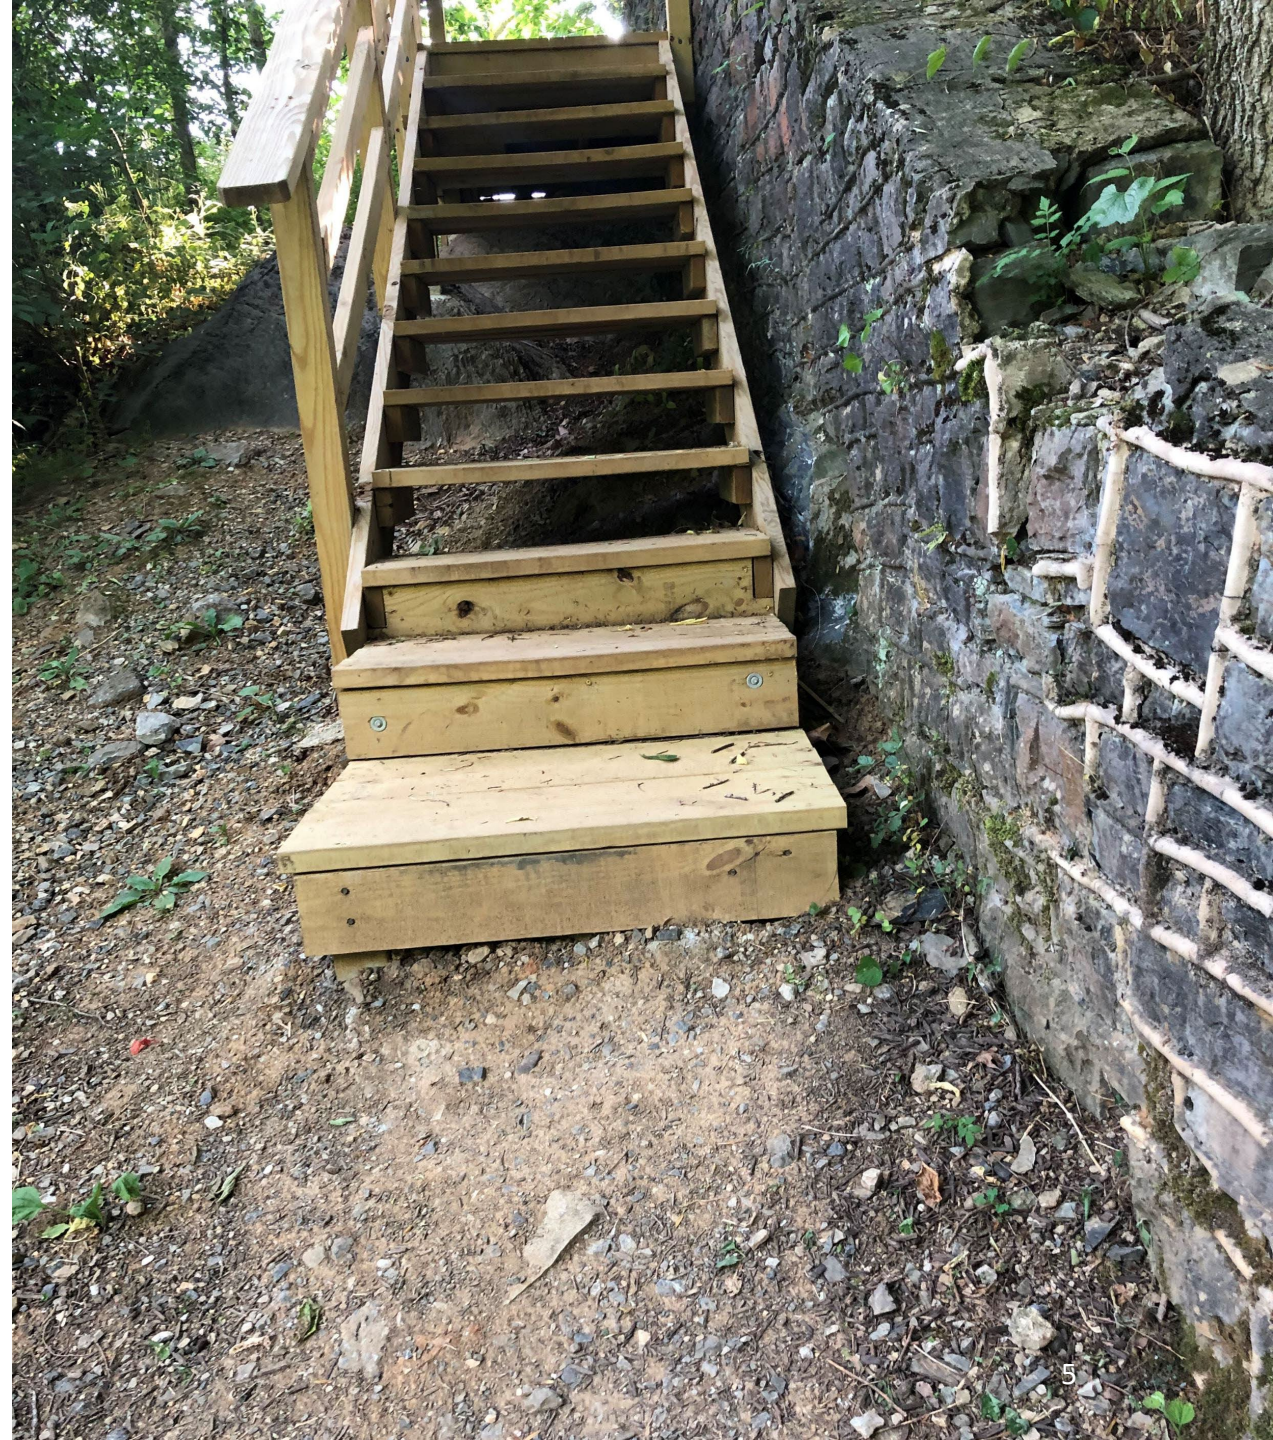
Rumsey Park*

- New wooden staircase east of the monument
- Missing bottom step/ platform to allow for a “soft” landing off the staircase
- Is another section of handrail needed?
- Repair criticality: Critical*

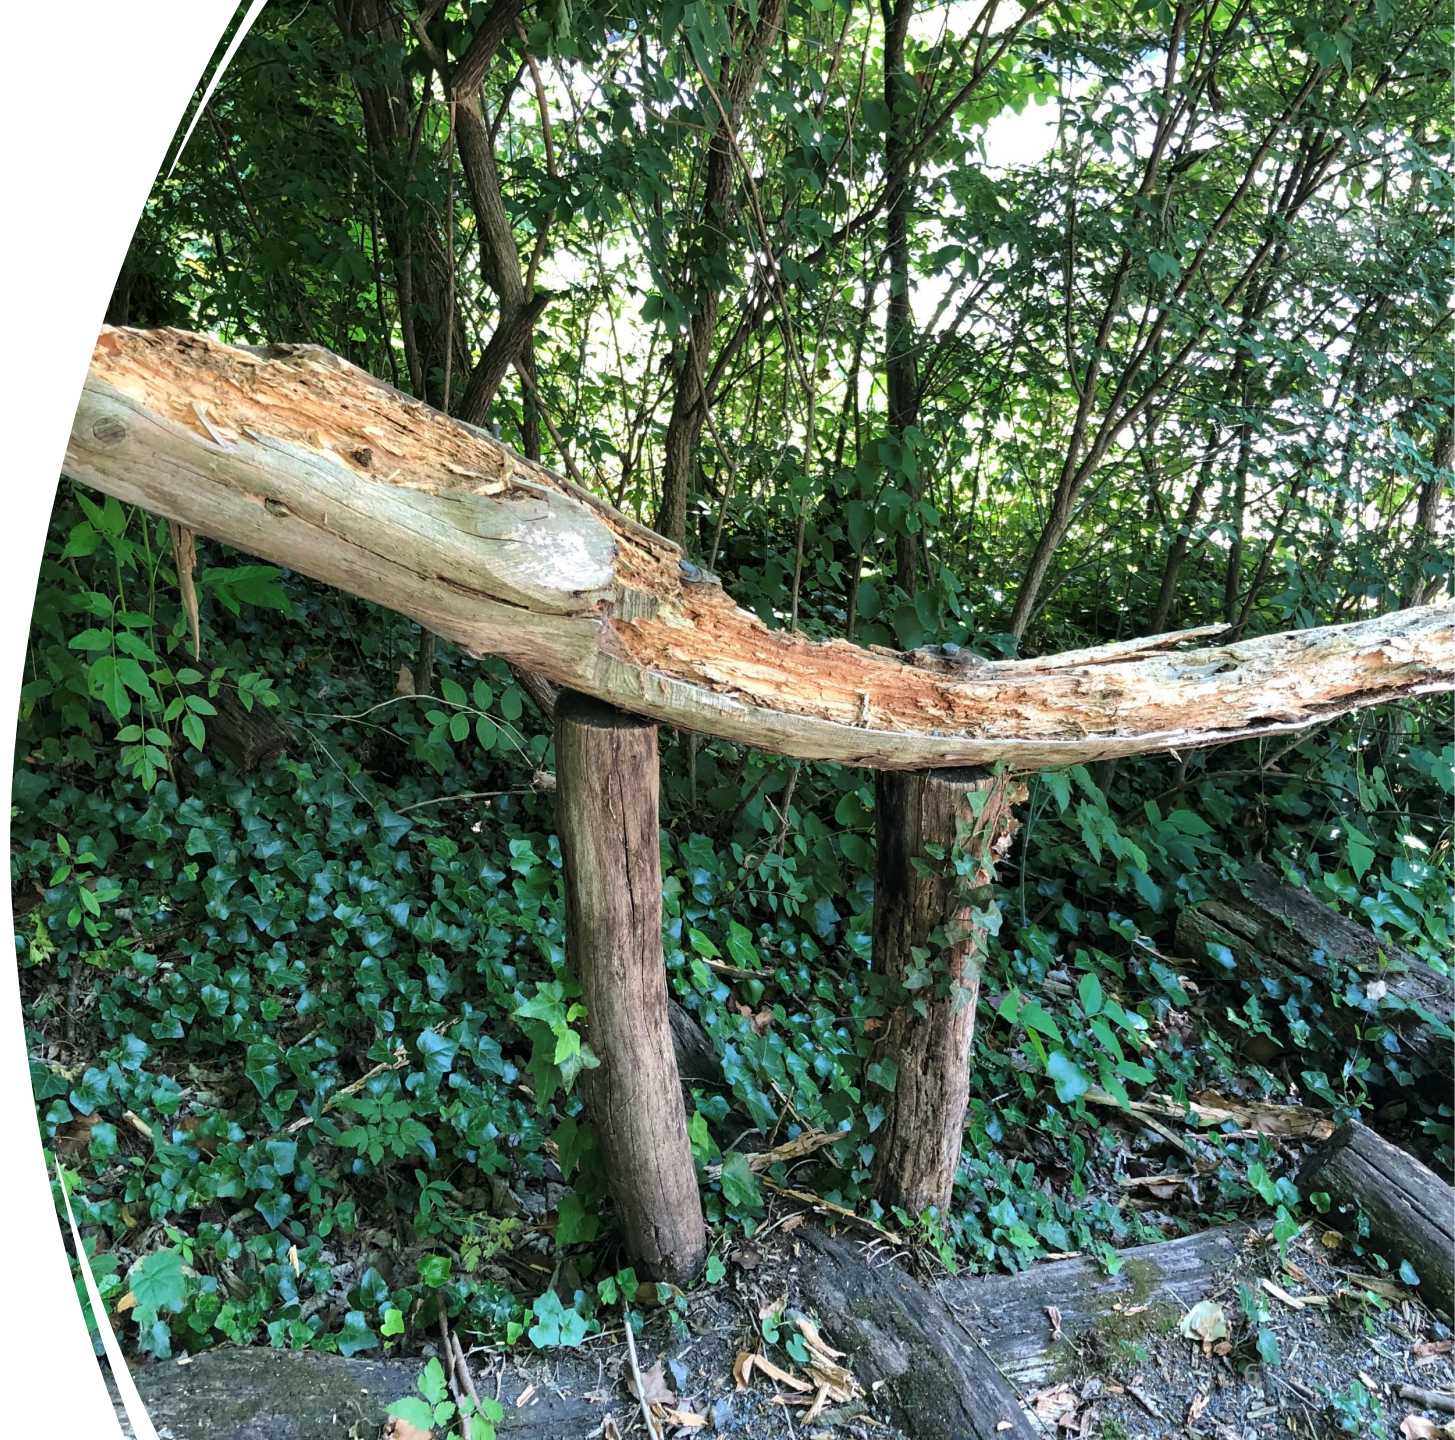
Cullison Park*

- Stair rail from Cullison Park to Mill Street is needed by many to safely use these stairs
- Repair criticality: Critical*

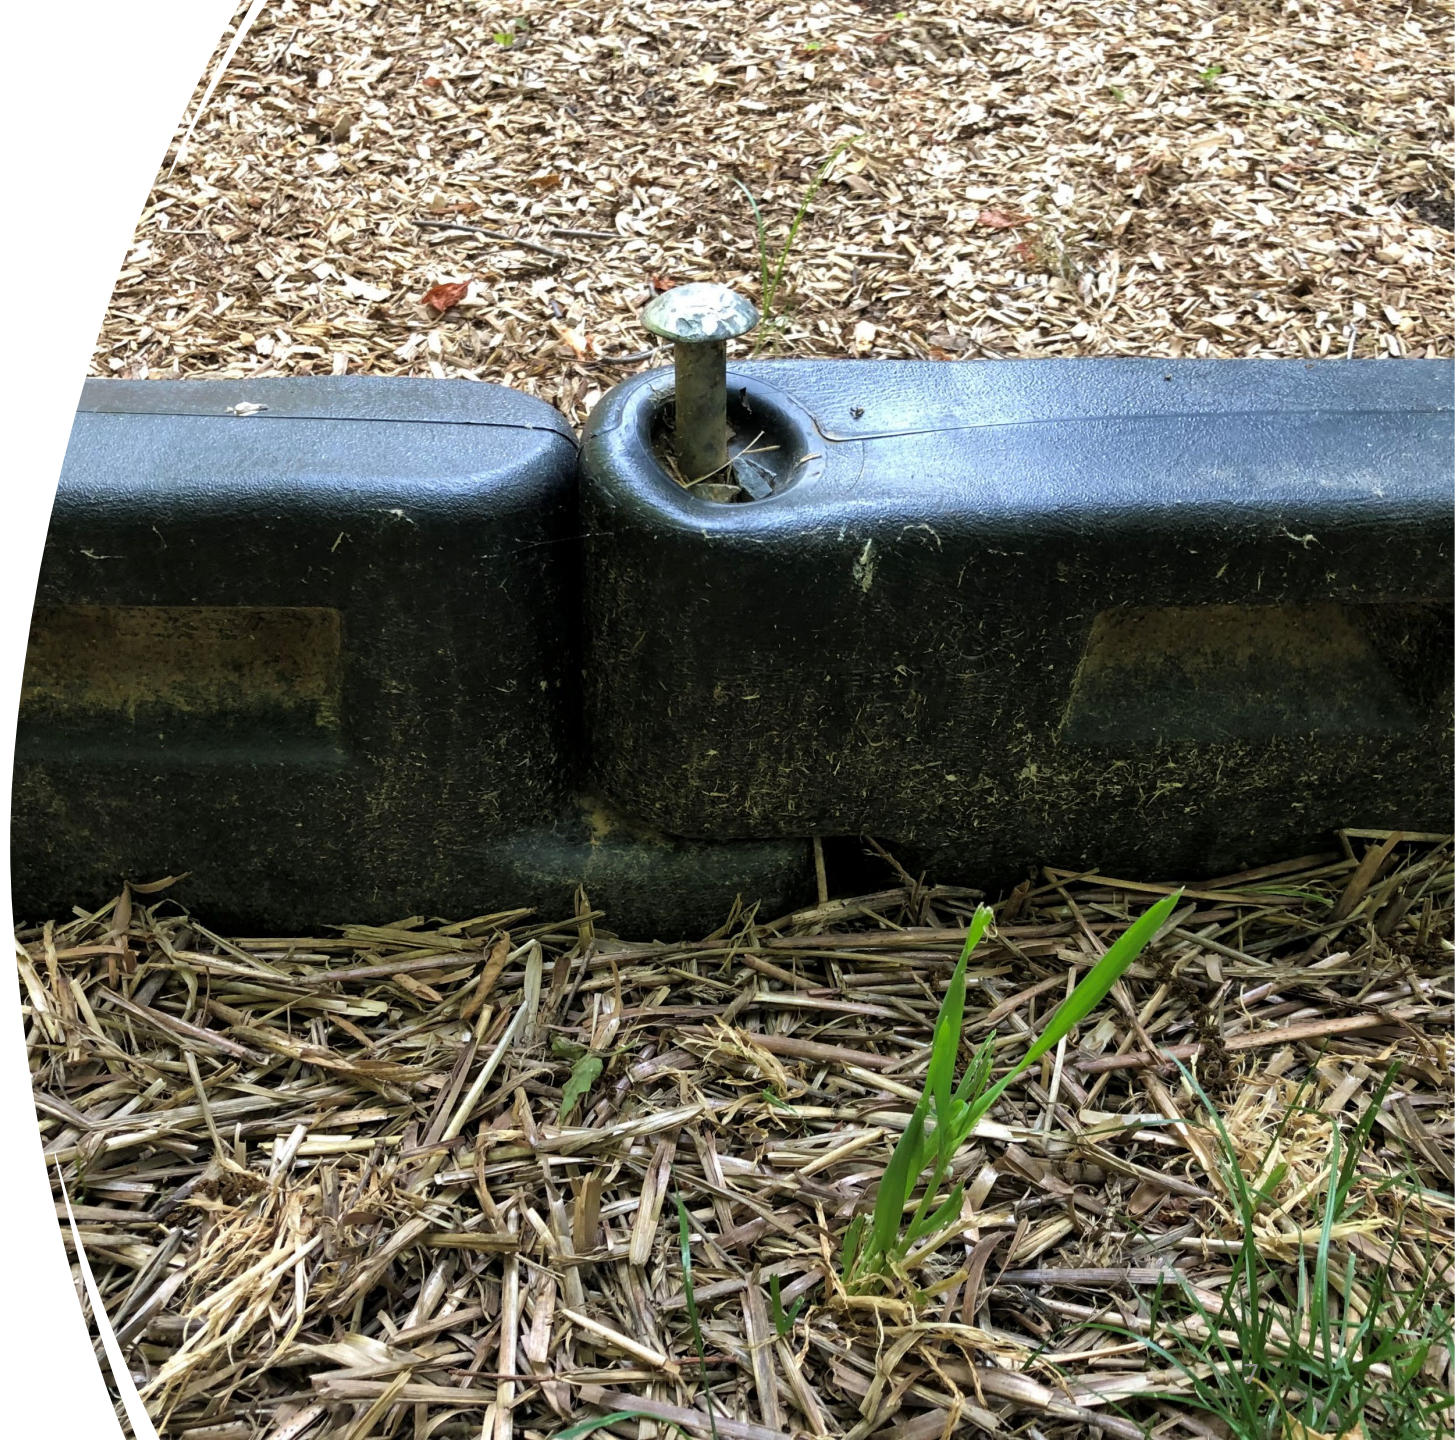
Cullison Park*

- The playground edging has nails popping around the ring
- Repair criticality: Critical*

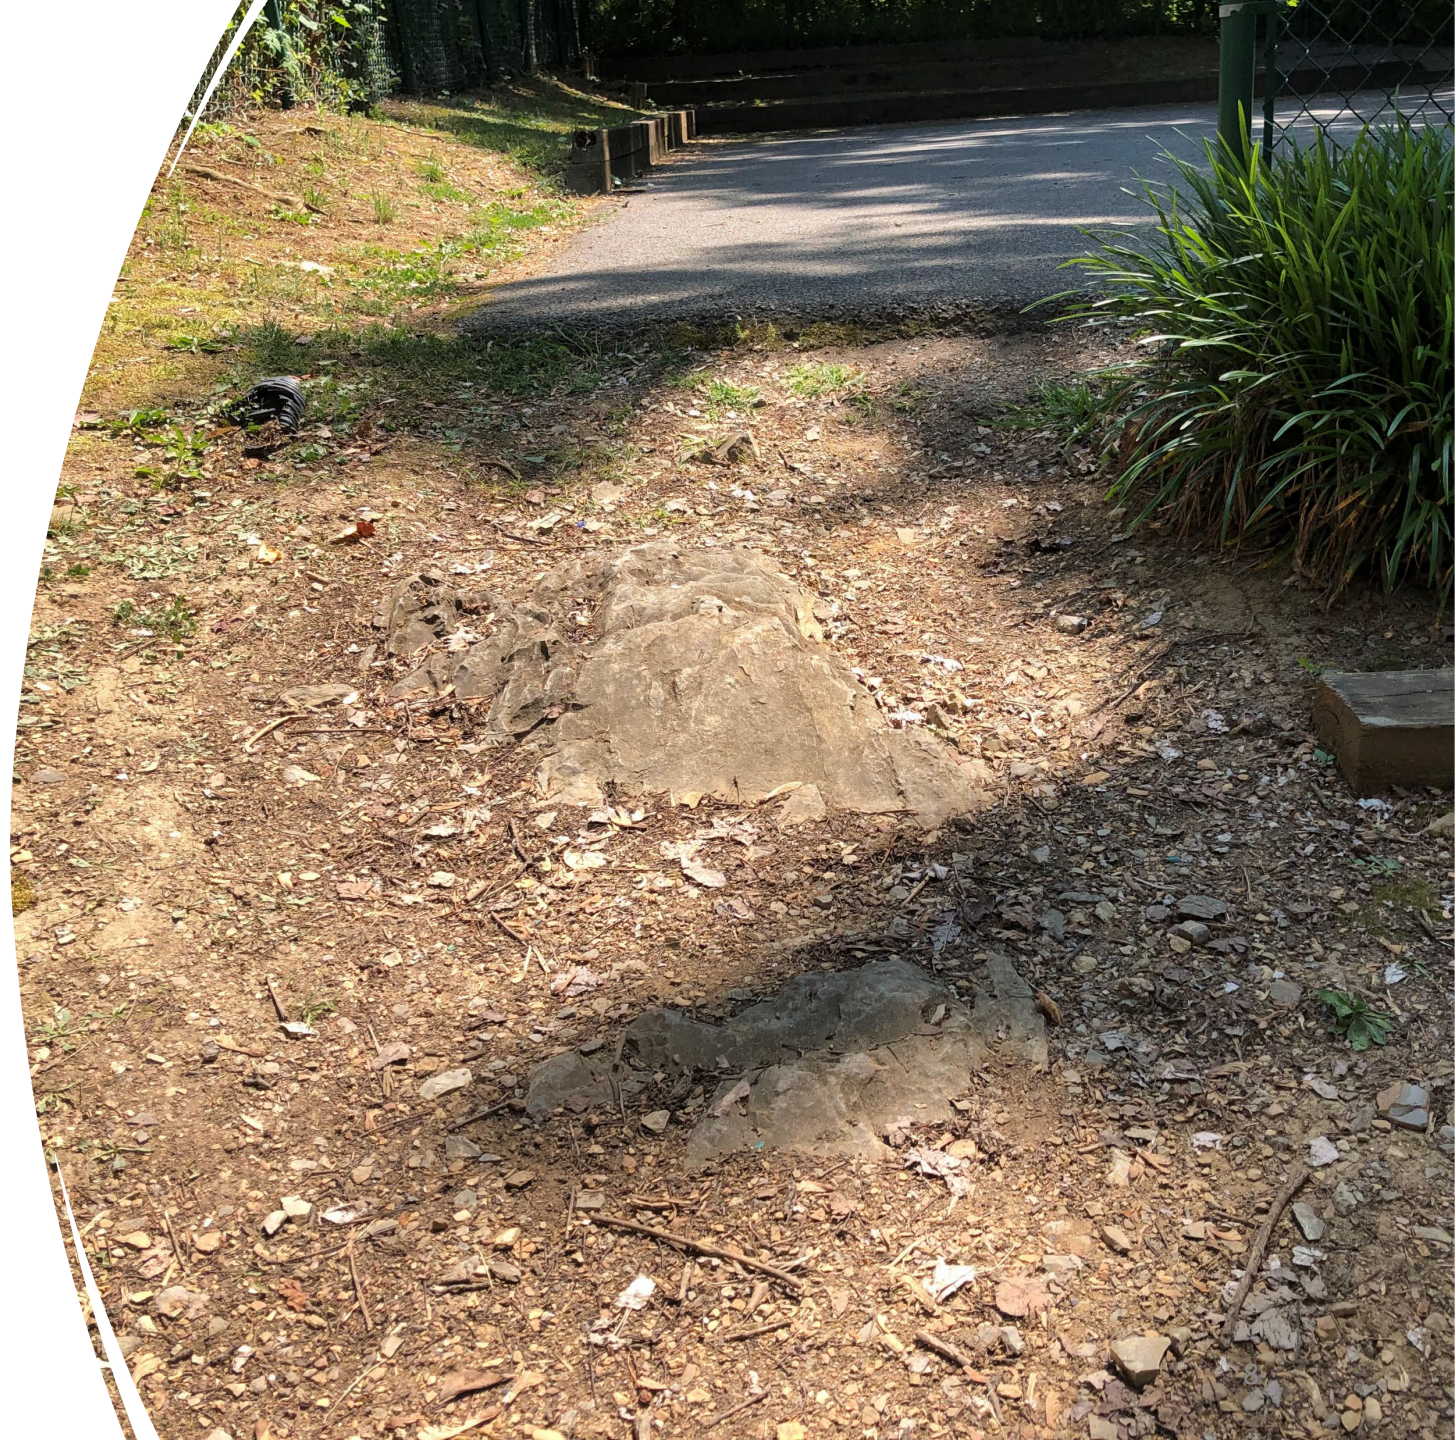
Viola Devonshire Park

- Large slab of rock directly in walkway
- In front of basketball court from playground
- Should be marked , perhaps with safety reflective paint, to be more visible
- Repair criticality: Moderate
