PUBLIC WORKS COMMITTEE AGENDA

THOUGHTS FROM ADA WALKABOUT TOWN OF SHEPHERDSTOWN JEFFERSON COUNTY, WEST VIRGINIA

TECHNICAL ASSISTANCE REPORT

Group reporting on issues found by description, location, repair criticality, and photos. Information on each location is included in this presentation.

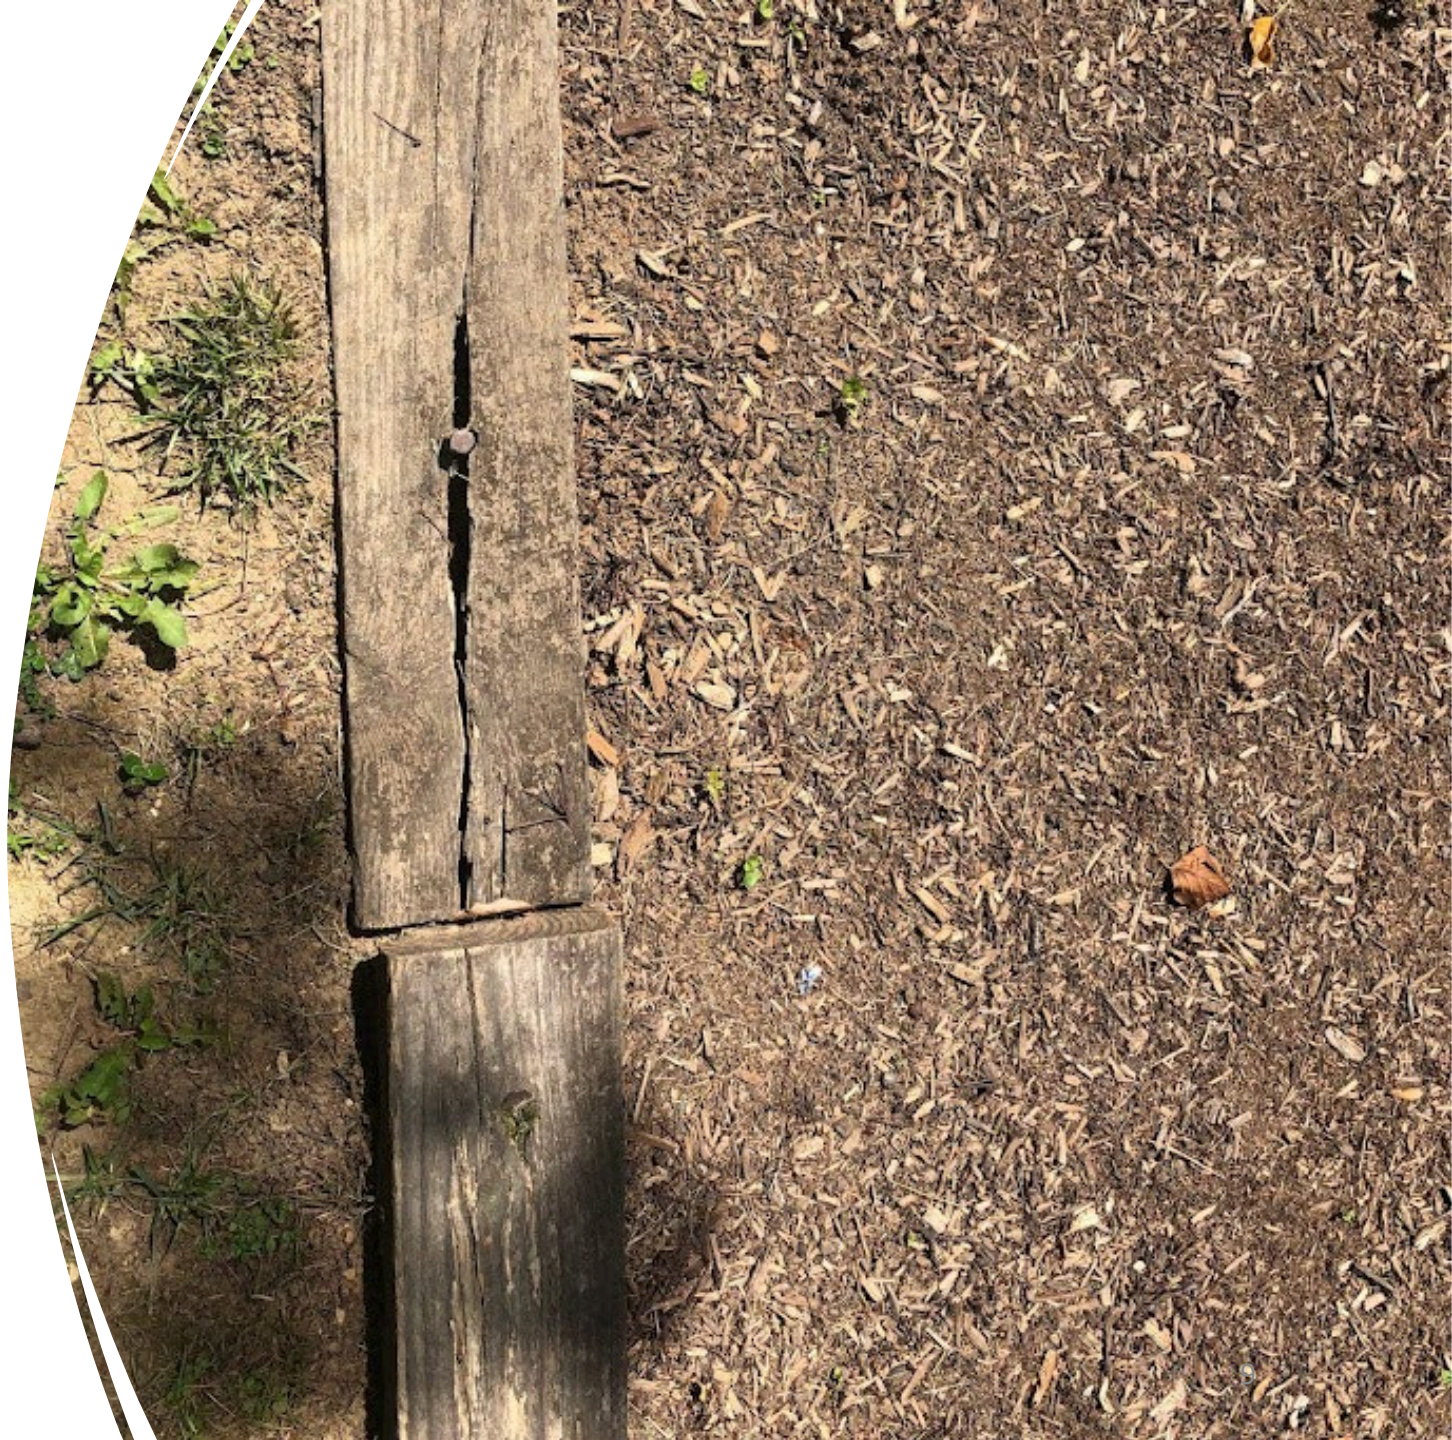
Viola Devonshire Park*

- Edging along walkway is rotting and rebar posts are exposed creating a dangerous tripping hazard
- Walkway along park playground and open space
- Recommend railing replacement
- Repair criticality: Critical*

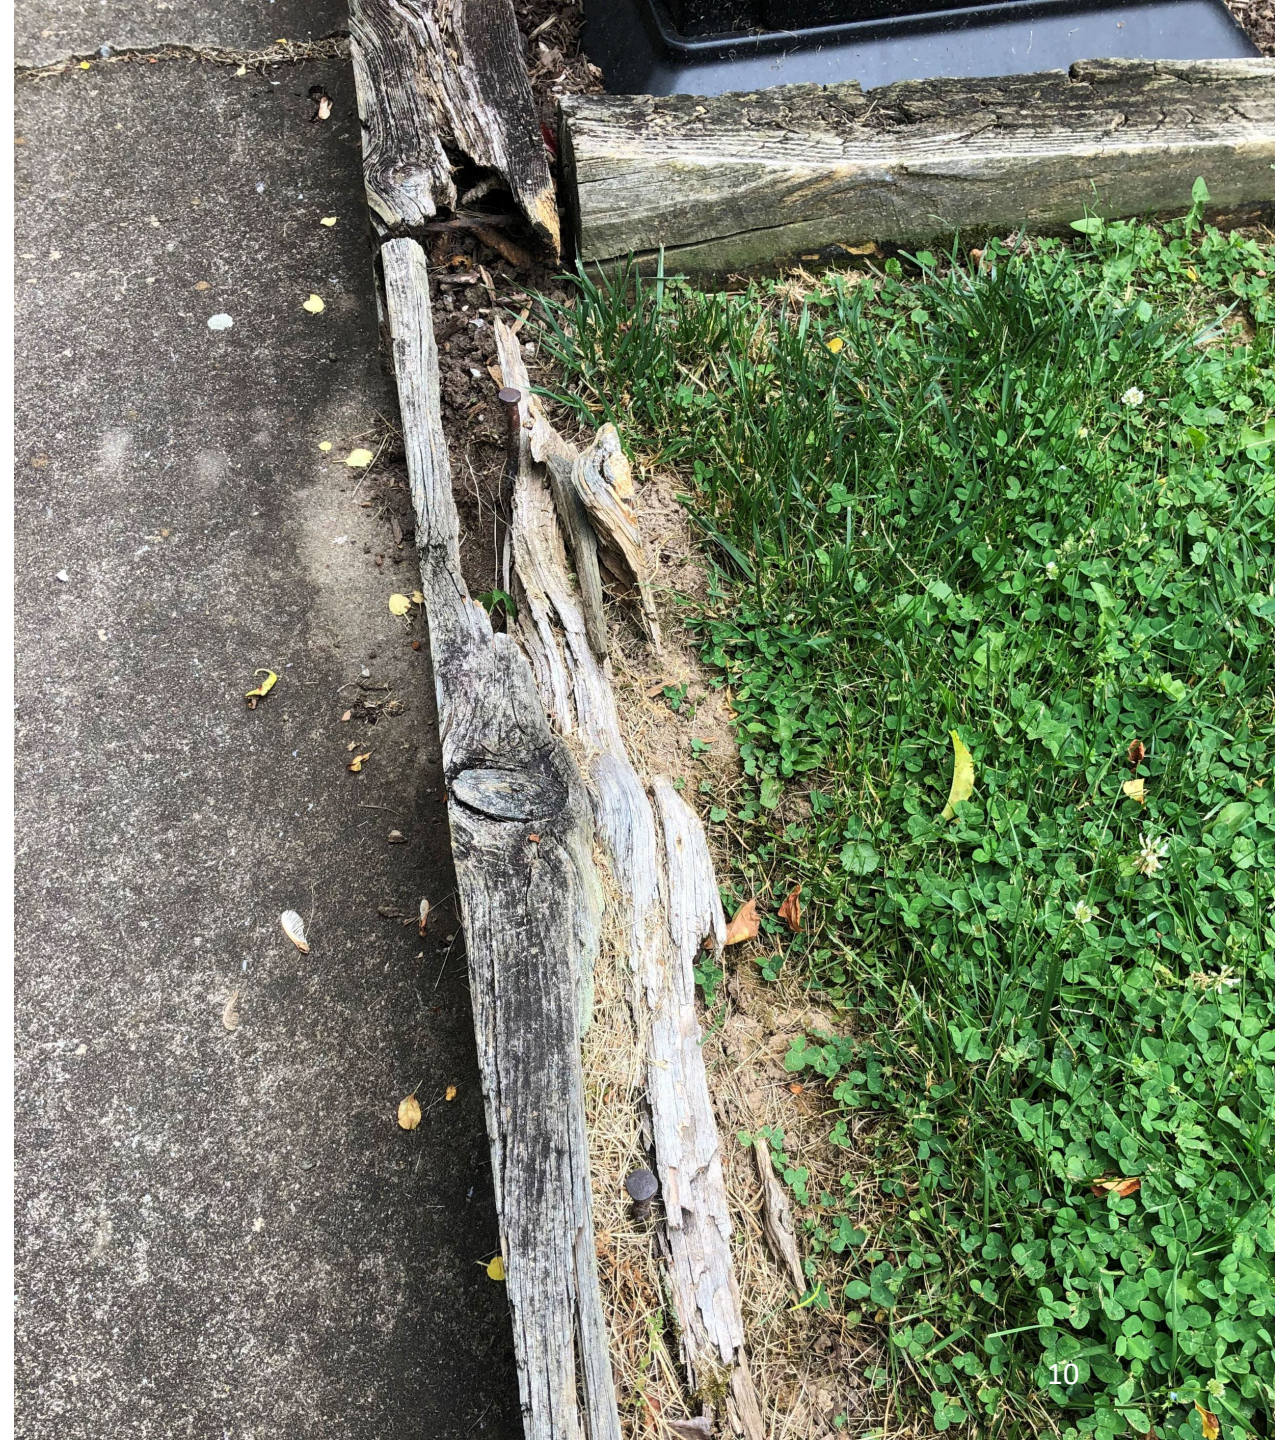
Viola Devonshire Park

- Showing the deterioration of the edging

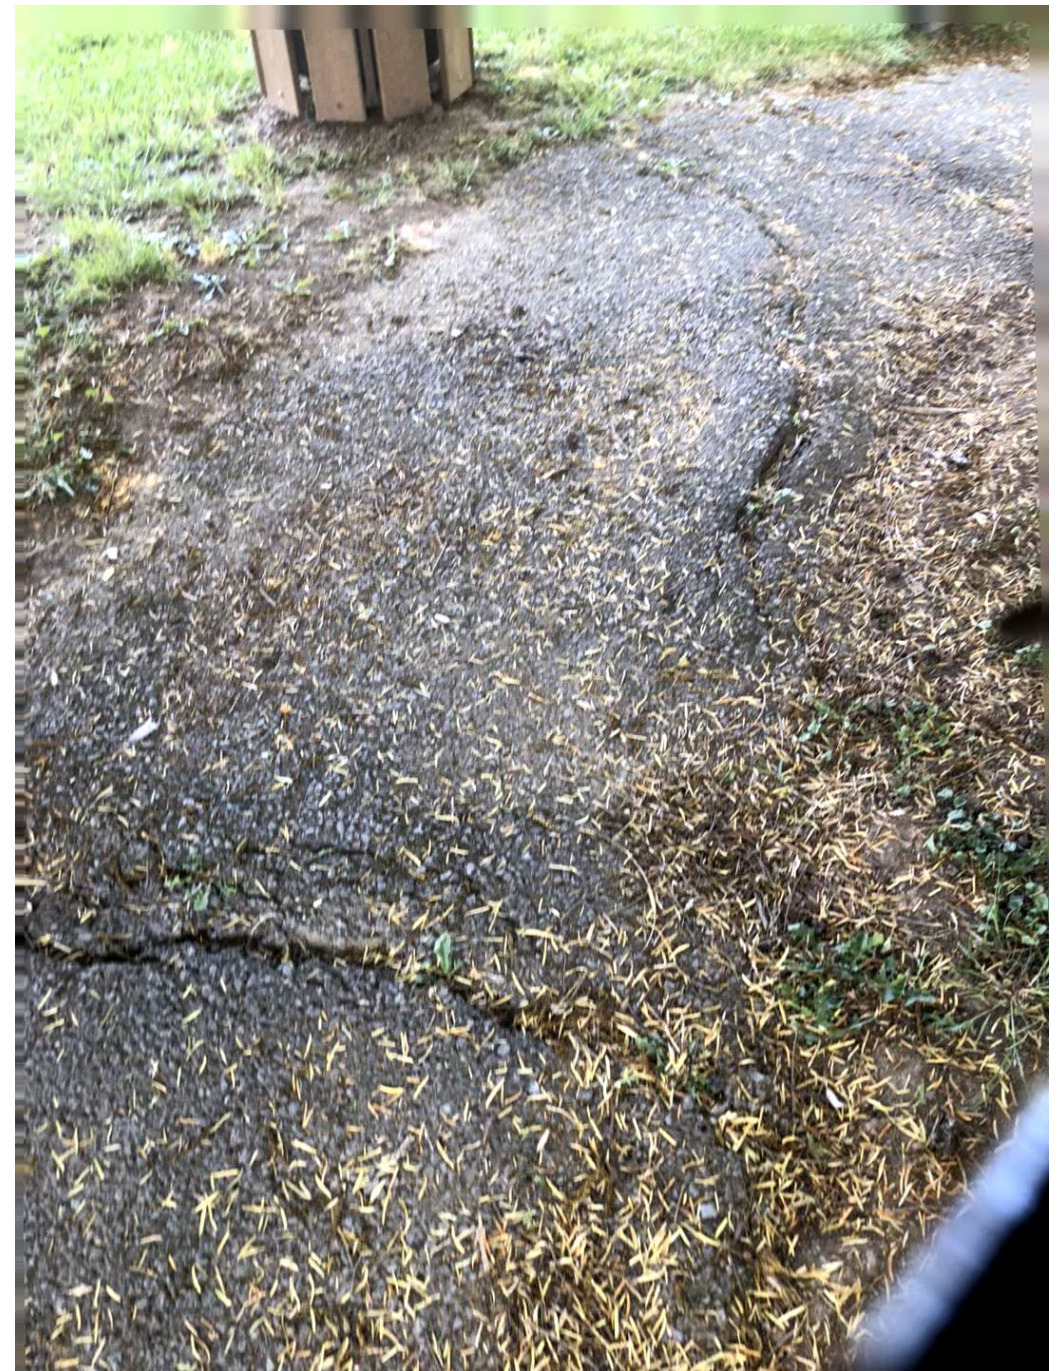
Bane Harris Park

- Along park walkway, there are numerous cracks in the asphalt/ black top.
- This photo is representative of them.
- Repair criticality: Low

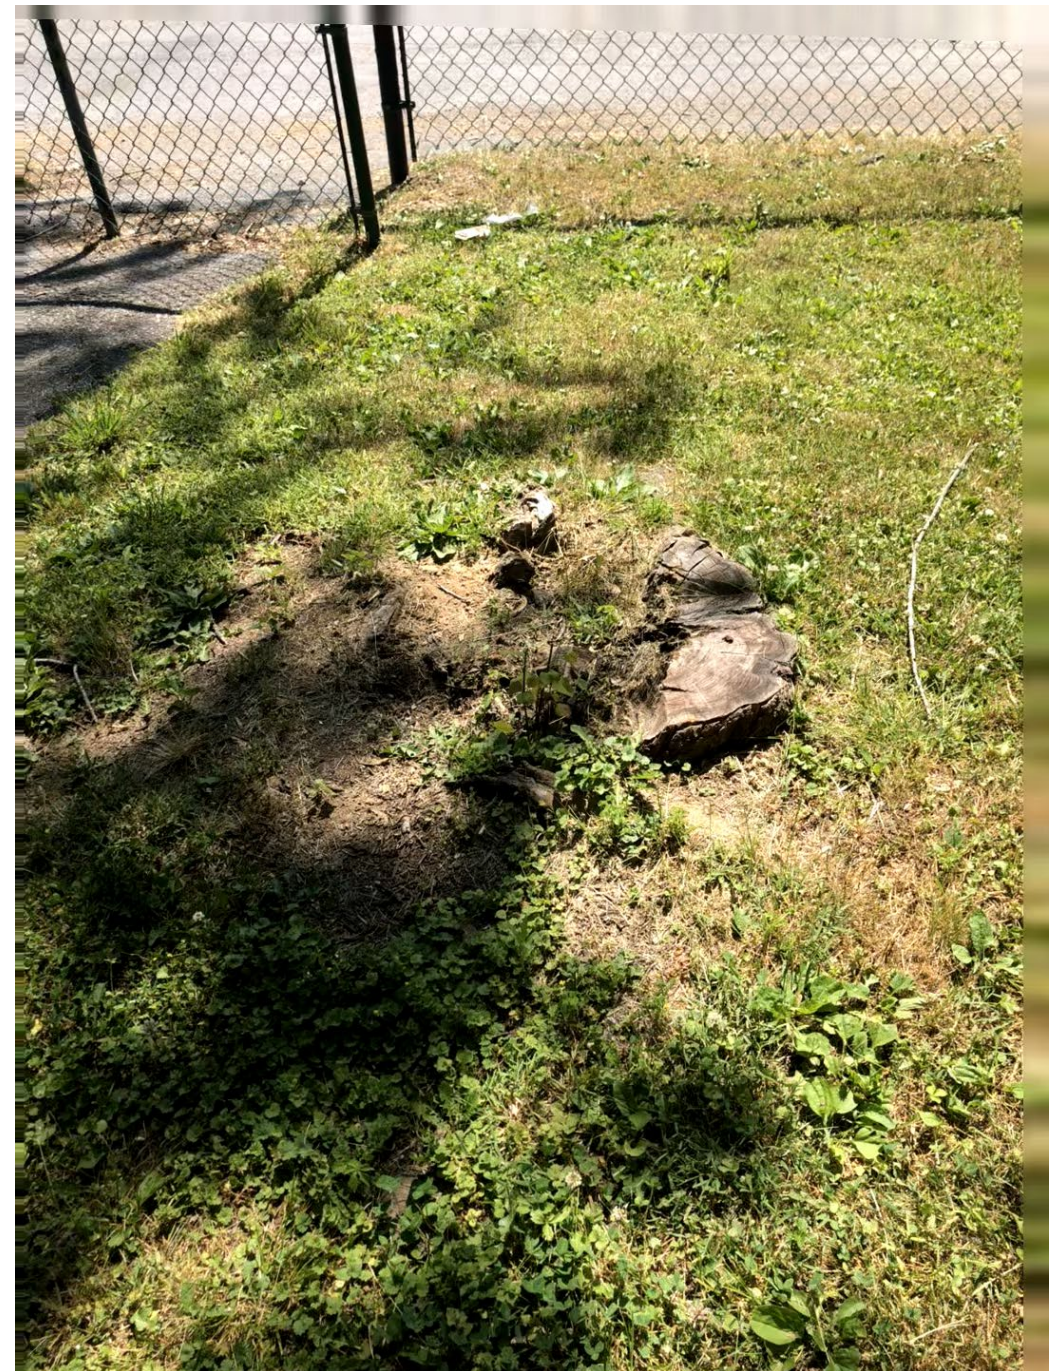
Bane Harris Park

- A tree stump near the entry is both sinking and part of tree trunk sticking out .
- Repair criticality: Moderate

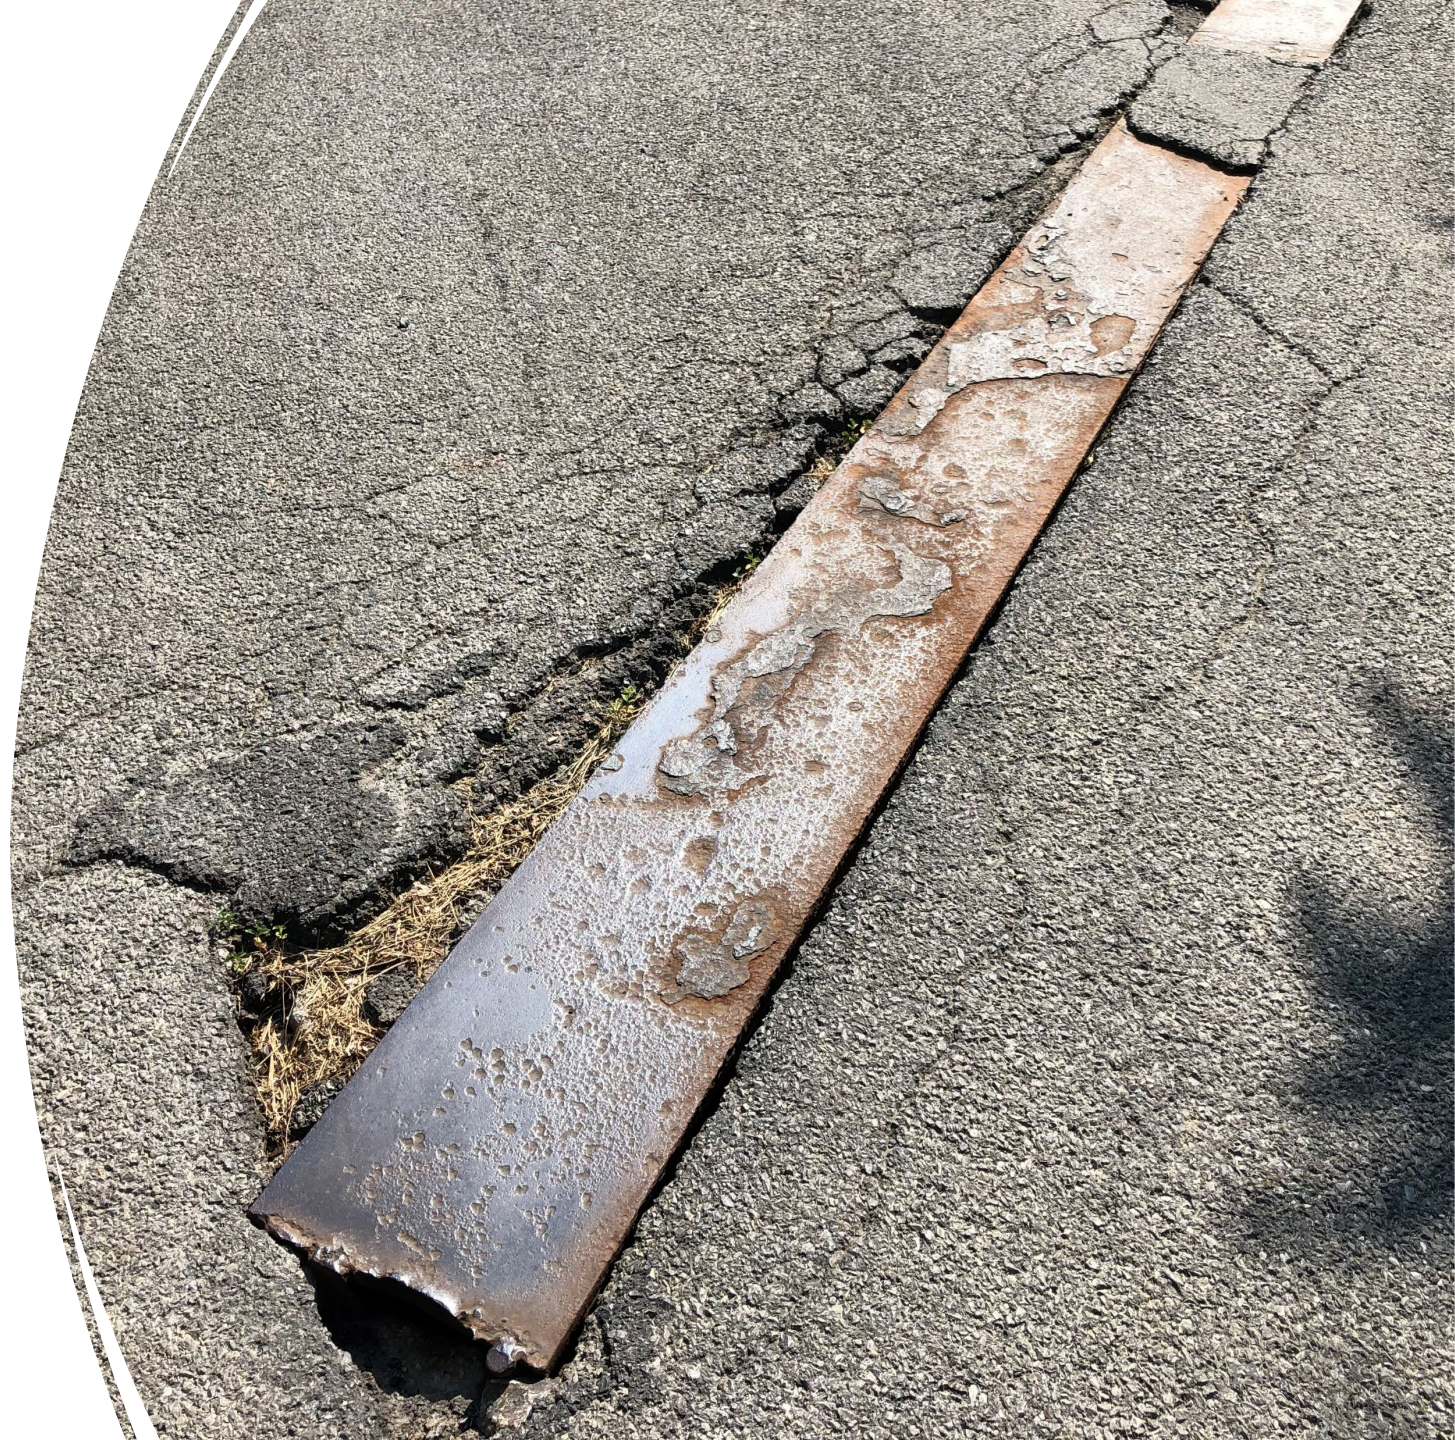
Riverfront Park

- In road tripping hazard
- On Princess Street enroute to the park, past most of the residences
- Repair criticality: Moderate Since there is no sidewalk people walk in the street

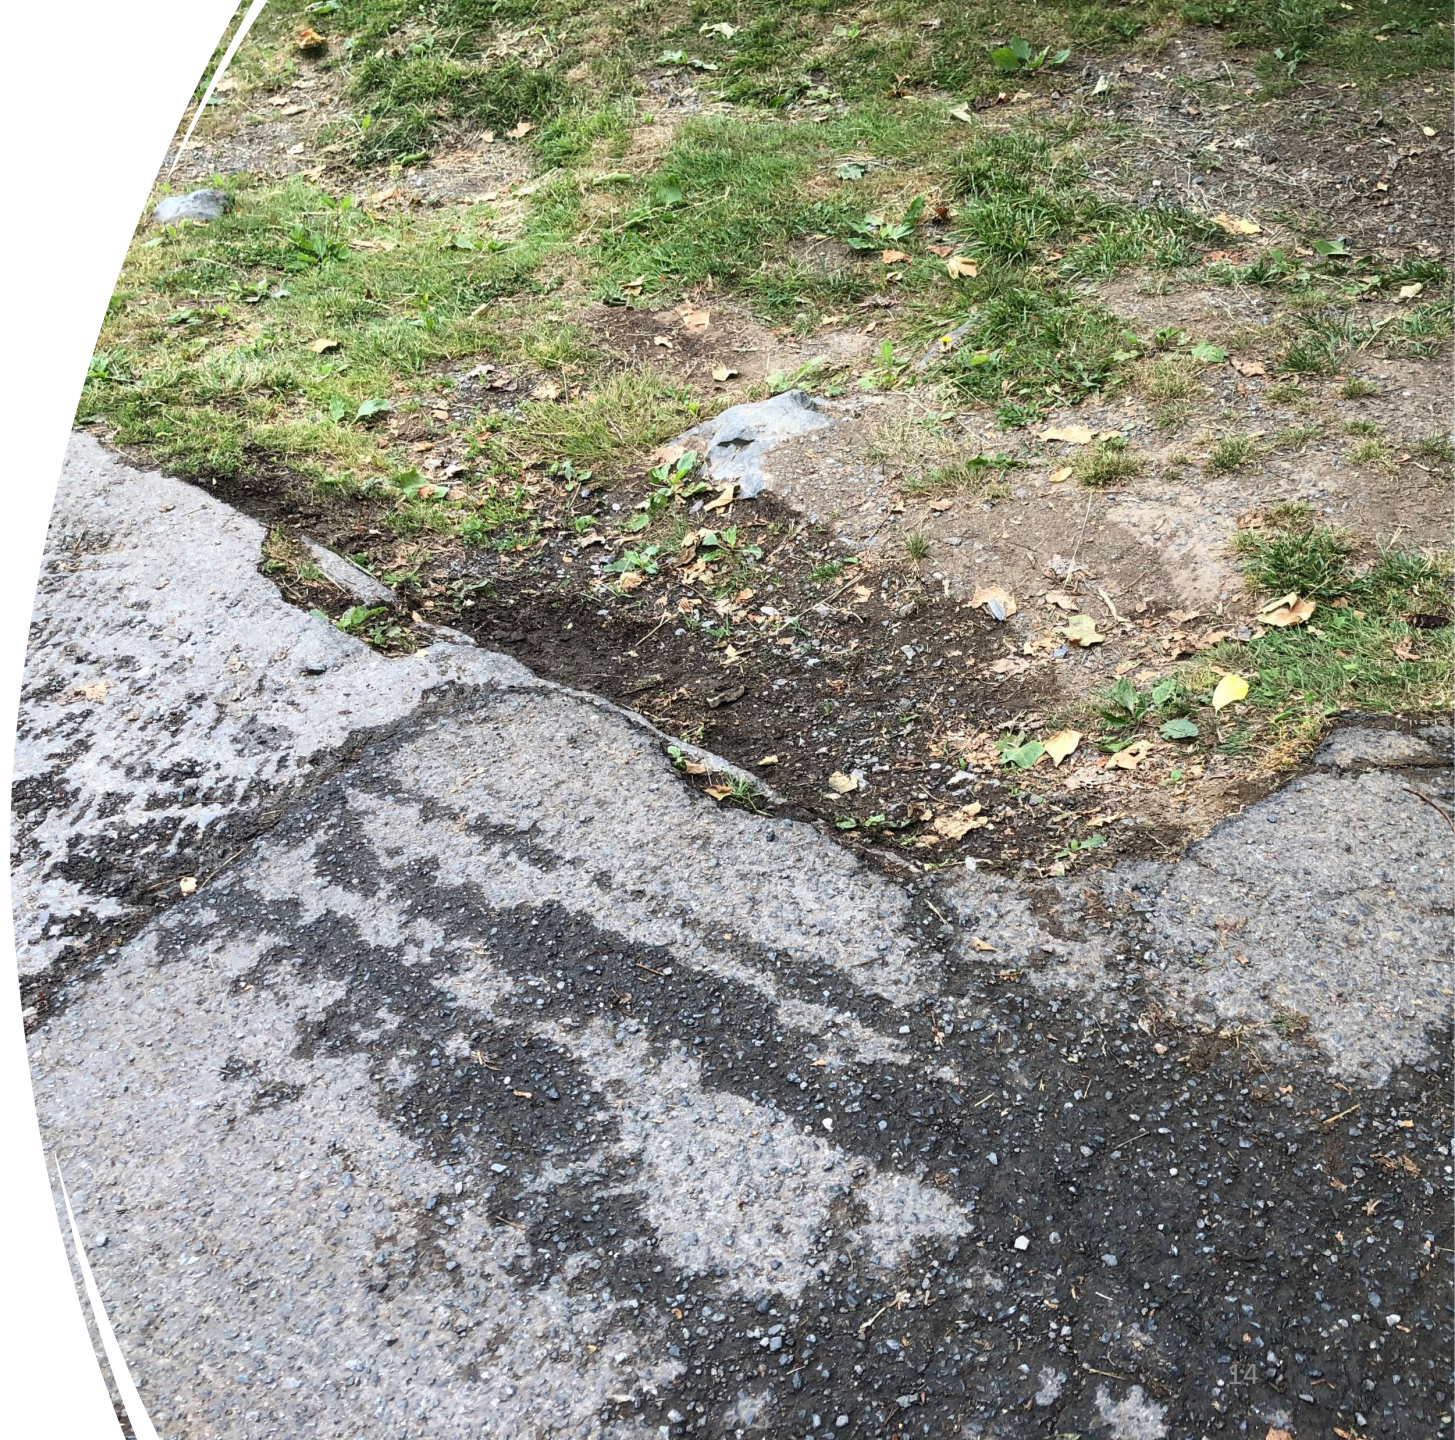
Riverfront Park

- Drop-off along side of ramp
- Repair criticality: Low

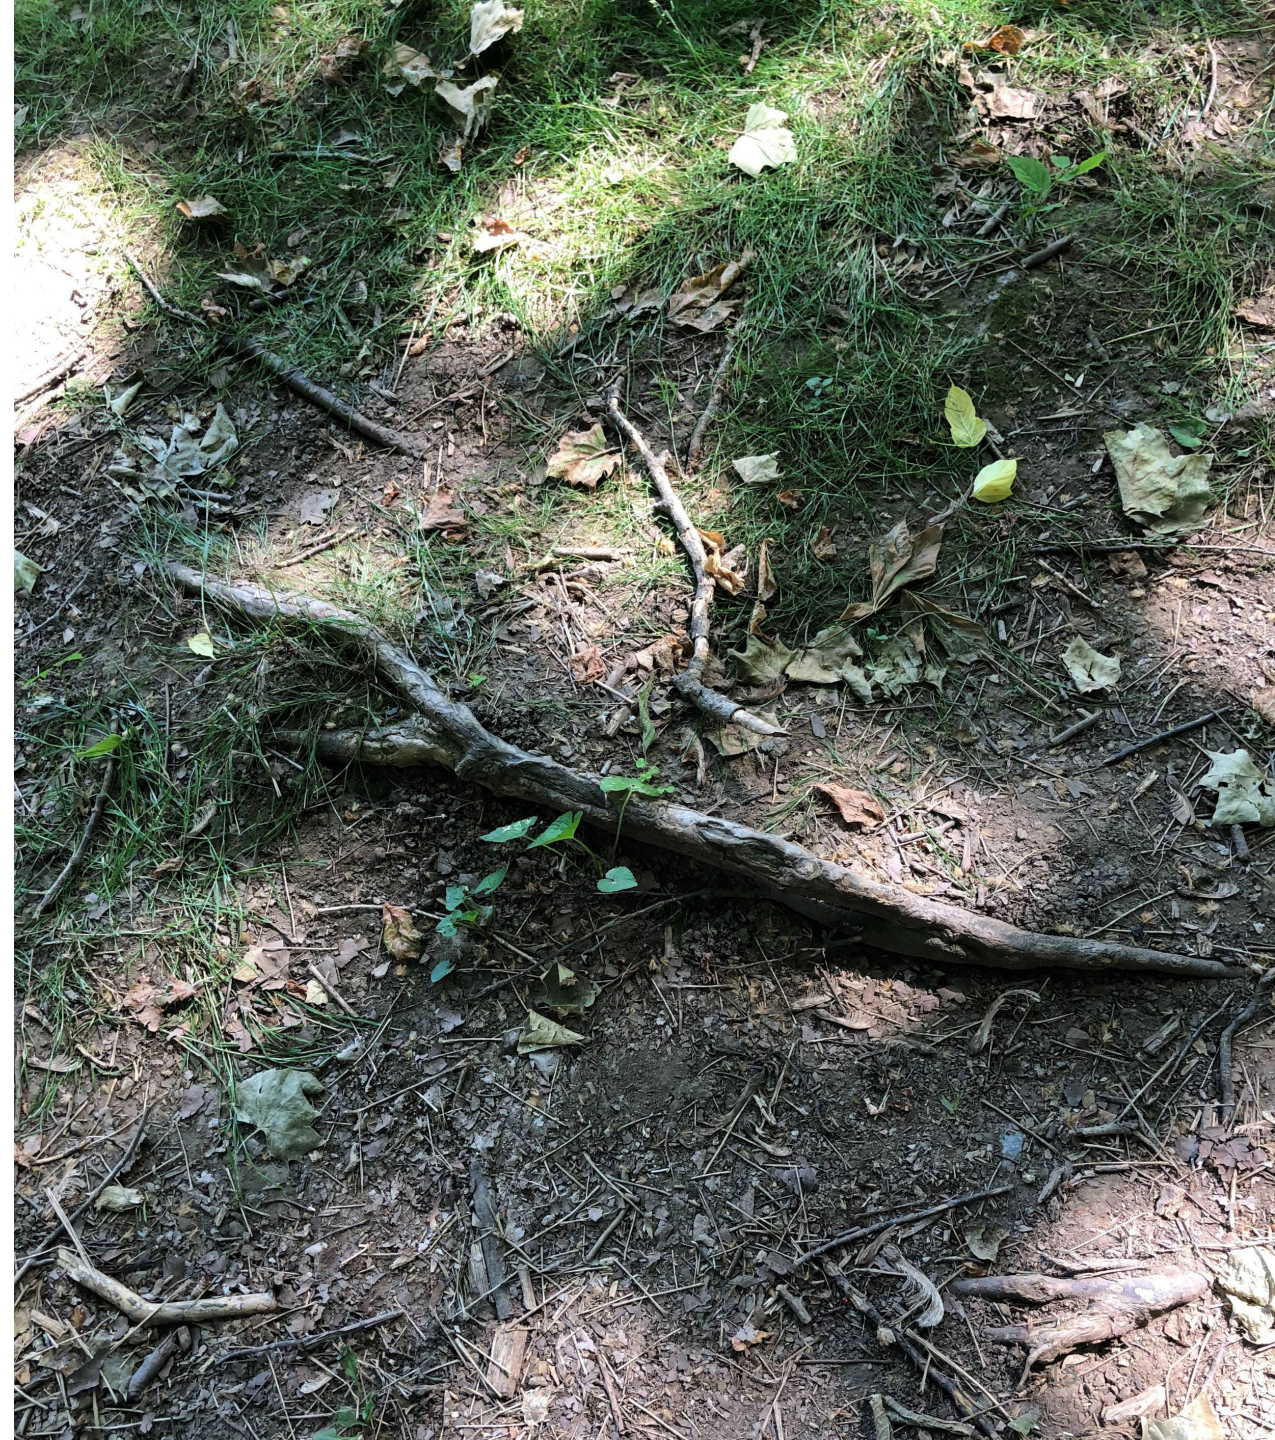
Riverfront Park

- Along the walking path, there are numerous thick roots that create a network of tripping hazards
- The tangle of roots create a significant tripping hazard. Recommend removing many of the roots.
- Repair criticality: Moderate
