Special Public Works Committee Meeting
Wednesday, August 30, 2023
1:00 p.m.
Town Hall

THOUGHTS FROM ADA WALKABOUT TOWN OF SHEPHERDSTOWN JEFFERSON COUNTY, WEST VIRGINIA

TECHNICAL ASSISTANCE REPORT

Sidewalk Survey 2023

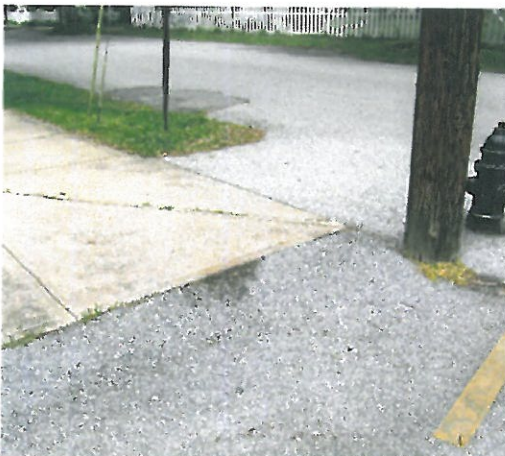
Sidewalk to street transitions on southwest corner of S. Church and W. New Streets can be seen here. The gradients are too steep and the grade breaks too sharp. There are no detectable warnings where the ramped surface meets the street.

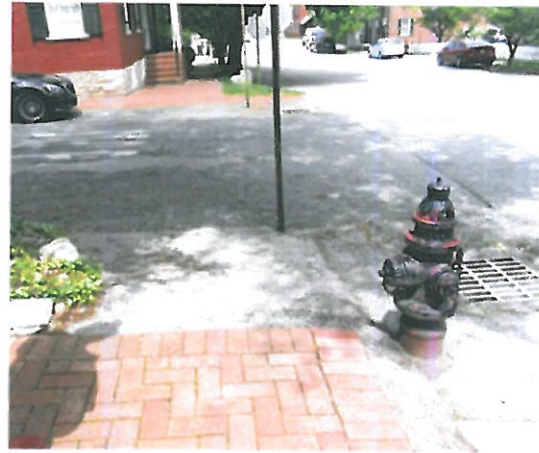
Sidewalk to street transitions on southwest corner of E. New and S. King Streets are shown here. There are concerns with ramp gradients and surface condition, including a drainage grate with large (non-compliant openings) in the path of travel. Wheels of a manual wheelchair or a walker could easily drop into the openings. Since the curb is missing, detectable warnings are needed at the bases of the ramped surfaces.

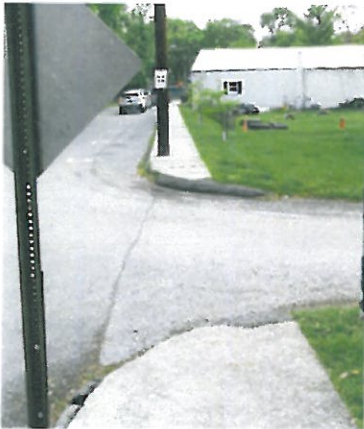
As shown, there are no curb ramps at intersection of W. High Street and N. Maiden Lane. The lack of ramps here is a concern given that Bane Harris Community Park (a destination) is adjacent to this corner. Parks should be accessible to all.

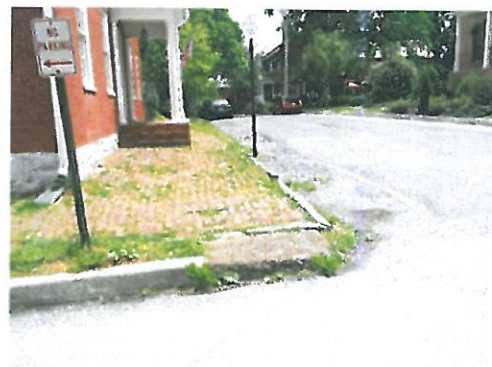
No curb ramps at northeast corner of S. Church and W. New Streets.

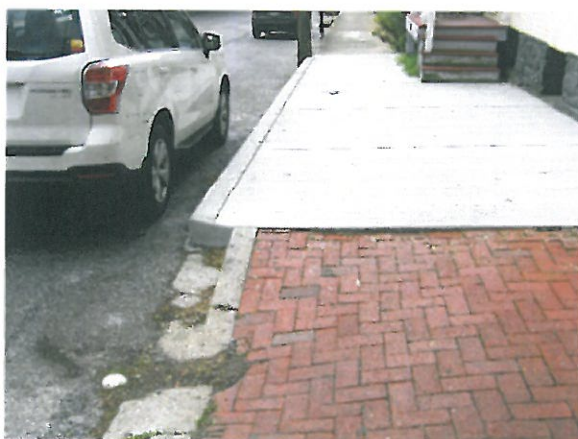
A significant number of changes in level, like that shown here, were observed in walkway surfaces. Such elevation differences often occur at joints in the sidewalk or, as depicted here, at the intersection of different surface types.

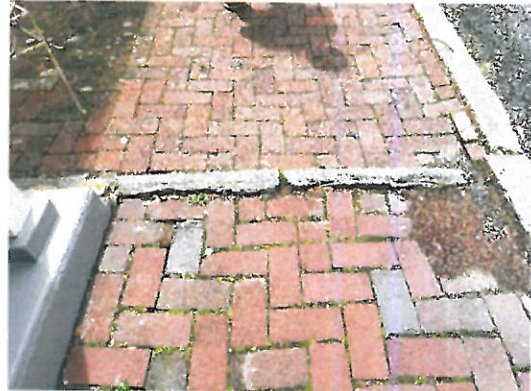
At a number of locations, limestone “inserts” were noted in brick sidewalks. The purpose of these features is not known. Nor is it known if they represent historical artifacts. In many instances, as shown here, the height of the “insert” exceeded ¼-inch vertical, creating an accessibility barrier for the mobility impaired and could facilitate trips and falls for all pedestrians,

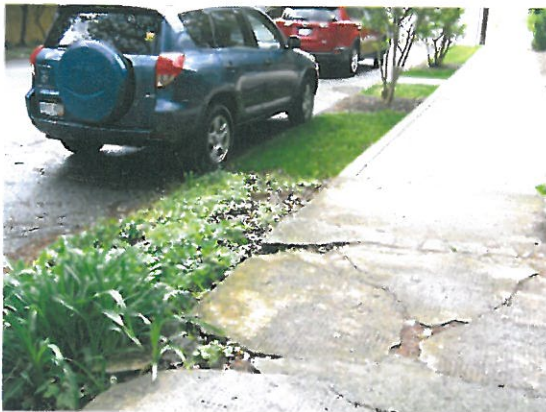
E. High Street

Depending on the magnitude of the irregularity, deteriorated surface condition can create a barrier to accessibility and/or a safety concern. A large number of locations, both on concrete sidewalks and brick sidewalks, were observed where surface discontinuities existed. Two representative locations are depicted here

As part of the aforementioned self-evaluation, it is suggested that the Town identify the locations of surface discontinuities, both changes in level and deteriorated surface condition, which represent barriers to mobility. Then a prioritized list of the locations needing barrier removal along with the modifications necessary should be developed including a schedule of when the barriers will be removed.

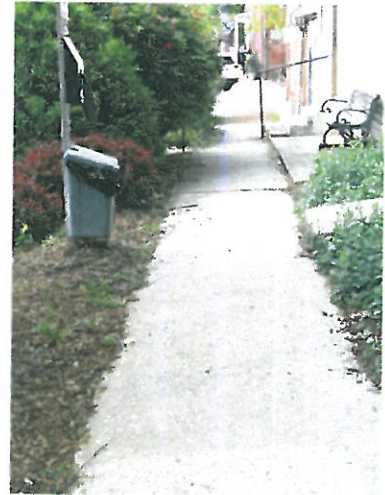
The photograph shows the sidewalk in the area of Town Hall. The sidewalk itself has adequate width. However, notice in the background that shrubs overhang the sidewalk. These create a protruding object hazard for visually impaired pedestrians since the vegetation cannot be detected with a long cane. Beyond the shrubs, ground-type vegetation in the form of lilies, extends a significant distance over the sidewalk. Both the shrubs and the ground cover vegetation reduce the effective width of the sidewalk to less than the required 4 feet for all pedestrians. Property owners should be required to trim/prune vegetation as needed to maintain an accessible sidewalk width, without protruding objects.

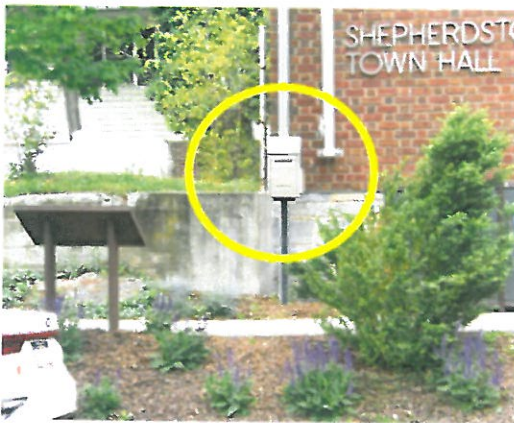
As shown here, there is a drop box located in front of Town Hall. However, the drop box is set back from the sidewalk and is too high to be accessible to an individual in a wheelchair. The box should be lowered and located immediately adjacent to a hard surface.

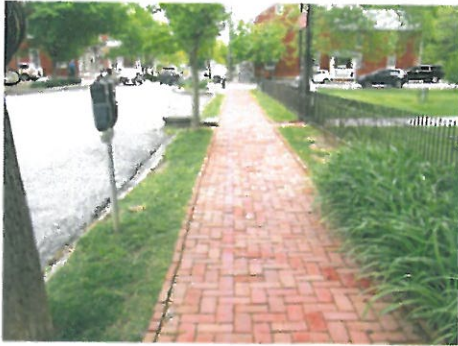
While the use of brick for sidewalks is attractive and relates to the history of the Town, to keep a brick sidewalk in accessible condition, like the one shown here on W. German Street, requires considerable maintenance. A brick surface (or even a stamped concrete surface) creates vibration for people in manual wheelchairs which can be excruciatingly painful to individuals with certain types of spinal cord injuries. Thus, the best practice is to make travel surfaces smooth concrete and place any color or texture in border areas.

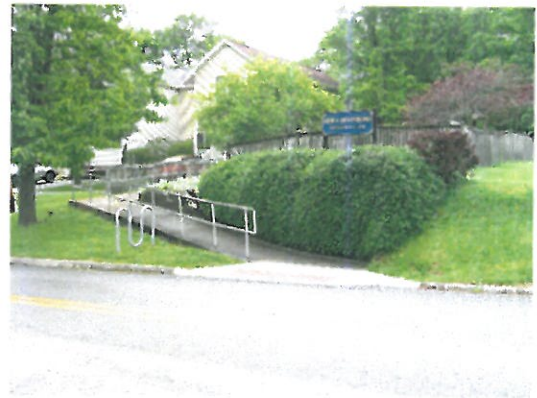
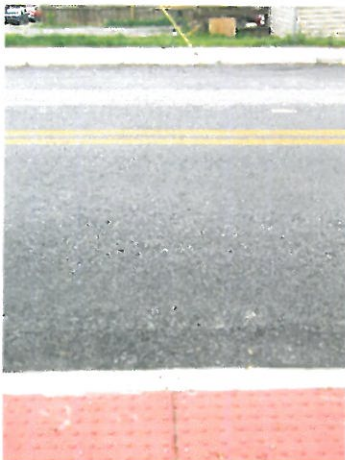
At the time of the walkabout, this section of E. German Street had been resurfaced and a new curb ramp, with detectable warning surface, installed on the south side of the street.

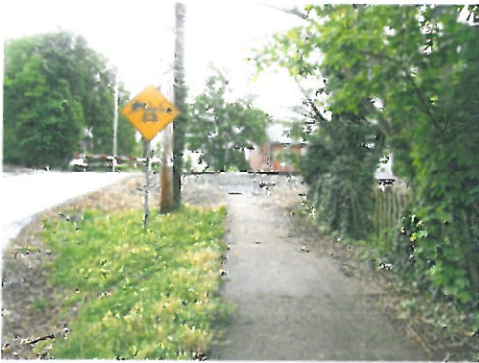
On the west side of the crossing, the roadway and south sidewalk grade are very steep, making a difficult traversal for all pedestrians but especially difficult for individuals with mobility impairments. Furthermore, due to periodic track raises by the Railroad, the walking surface at the tracks is humped and irregular.

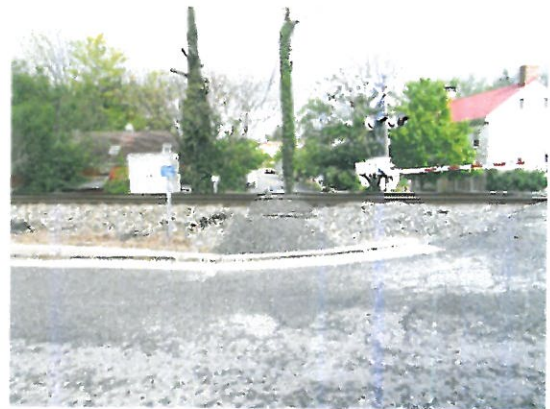
Although the grades are more favorable on the east side of the crossing and south side of E. German Street, there are still surface condition issues attributable to the track raises.

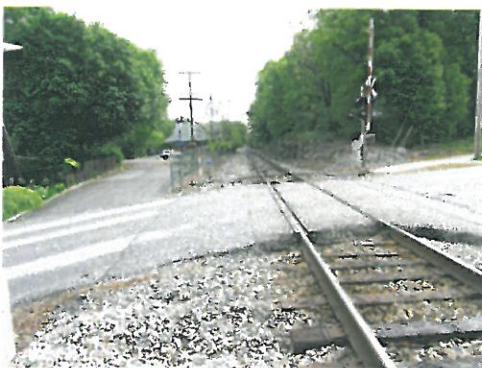
As shown here, due to the gradients involved, the crossing condition is no better on the north side of E. German Street. While not desirable from a safety standpoint, the best route over the crossing for an individual in a wheelchair would be to use the street.

Thus, the E. German Street grade crossing presents a real challenge for all pedestrians. To create an accessible route up to the tracks on the west side, also presents an engineering challenge. Such a route would require a switchback arrangement that may or may not be possible depending on right-of-way availability and the cooperation of Norfolk Southern. Other options for connecting the east side of Town with that west of the tracks should be explored.
