PUBLIC WORKS COMMITTEE AGENDA

THOUGHTS FROM ADA WALKABOUT TOWN OF SHEPHERDSTOWN JEFFERSON COUNTY, WEST VIRGINIA

TECHNICAL ASSISTANCE REPORT

Group reporting on issues found by description, location, repair criticality, and photos. Information on each location is included in this presentation.

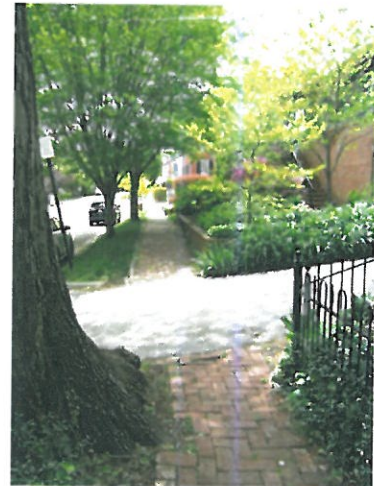
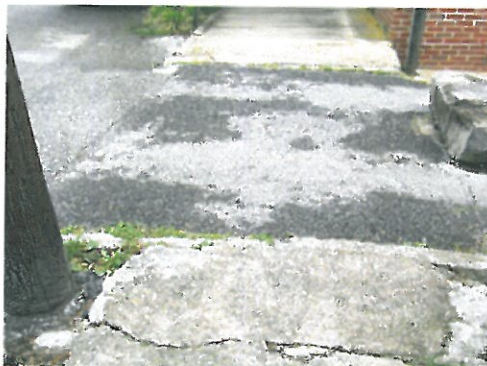
At a few alley locations, curbs or other vertical surface irregularities meant that there was not an accessible sidewalk crossing of the alley. In these cases, a smooth surface should ramp down flush with the alley.

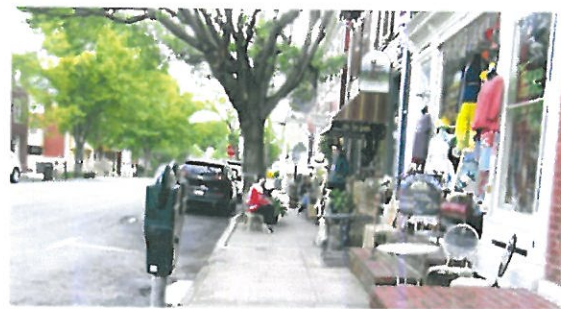
Street furniture (such as planters, seating, trash receptacles, bicycle racks and signs) is a desirable part of an active, vibrant streetscape. Outdoor dining, which has increased nationally since the Covid pandemic, is also considered to be street furniture. However, it is necessary that street furniture be located so that at least a 4-foot-wide clear unobstructed path of travel is maintained for the mobility impaired.

It is important to educate merchants and property owners about the need to maintain a 4-foot-wide clear path of travel (free from permanent and temporary obstructions) on sidewalks.

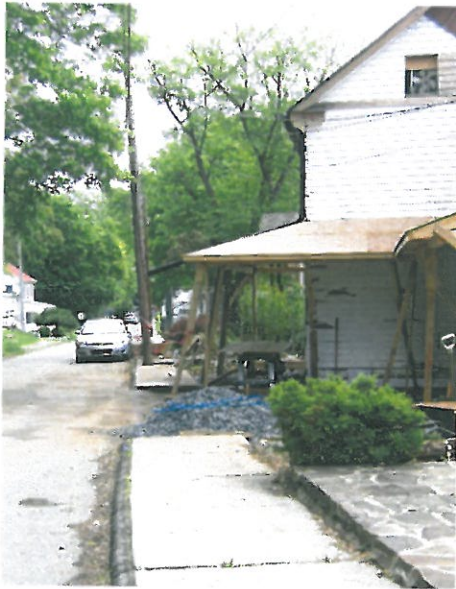
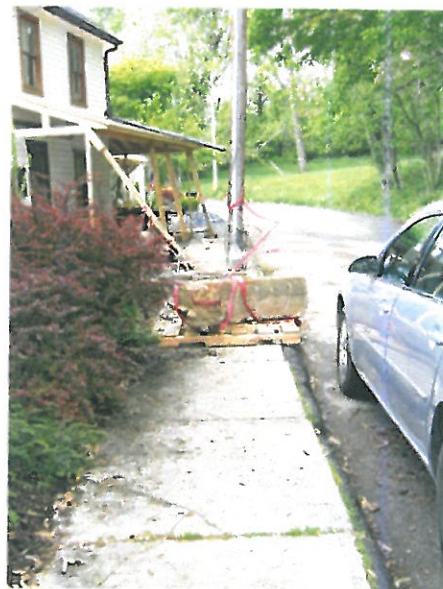
While these activities are temporary, they can and do block pedestrian travel paths and create safety issues for all pedestrians. PROWAG and the *Manual on Uniform Traffic Control Devices* require that sidewalk temporary traffic control be detectable and accessible

It is important that property owners, public works crews, contractors and utilities be advised of these requirements. Permits should be required when a sidewalk is blocked, even temporarily. The provisions of the permit should require that a detectable and accessible pedestrian route be maintained while the sidewalk is closed.

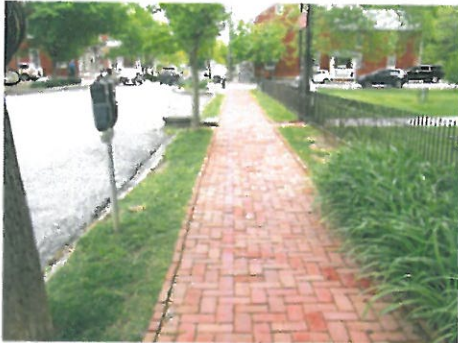
While the use of brick for sidewalks is attractive and relates to the history of the Town, to keep a brick sidewalk in accessible condition, like the one shown here on W. German Street, requires considerable maintenance. A brick surface (or even a stamped concrete surface) creates vibration for people in manual wheelchairs which can be excruciatingly painful to individuals with certain types of spinal cord injuries. Thus, the best practice is to make travel surfaces smooth concrete and place any color or texture in border areas.

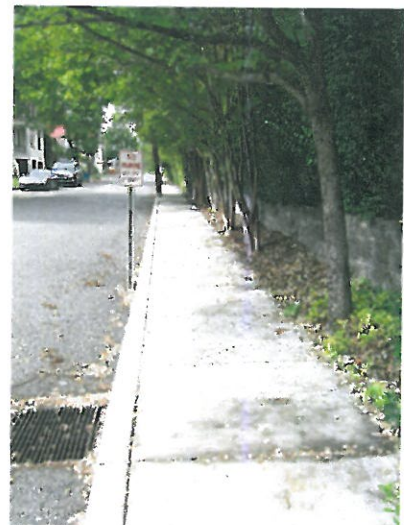
It appeared that sidewalks along N. Mill Street and E. High Street had recently been reconstructed. A section of the sidewalk along N. Mill St. is shown here. However, where the new sidewalk sections intersect in the southwest corner of the intersection, no detectable warnings were installed on N. Mill or on E. High. This corner should be high priority in terms of detectable warning installation. In addition, the requirement for detectable warning surface installation at curb ramps should be part of the sidewalk reconstruction specifications provide to property owners.

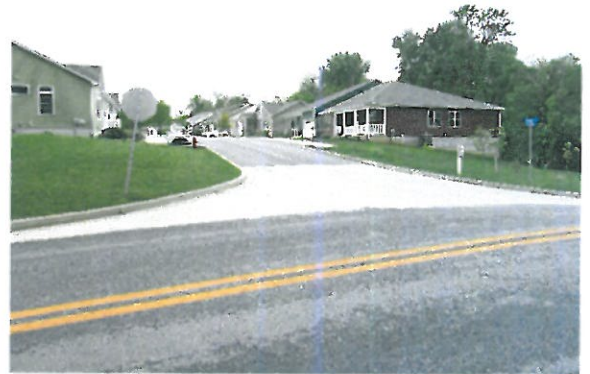
Sage Place--There are a number of relatively new homes on Sage Place, on the east side of Town. Sage Place intersects E. German Street on the south side. There are no sidewalks at this location on the south side of E. German and the sidewalk on the north side ends just west of Sage Place. Note that while there are sidewalks in front of the homes on Sage Place, there is no connection to E. German Street. In the future, consideration should be given to requiring developers to not only connect their sidewalks to the main street or roadway but also to construct sidewalks along the main roadway within the limits of the property. Such small sections are critical to creating a connected sidewalk system.

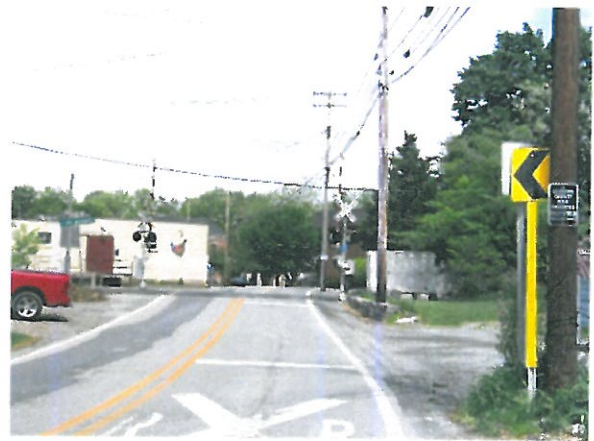
The third grade crossing in Town is at E. Washington Street. While this crossing is not as convenient to downtown or to campus as the E. German and E. High Streets crossings, as shown here, the topography is much more favorable. However, there is currently no sidewalk on E. Washington. There are also right-of-way issues, utility poles and railroad-related hardware that present challenges in creating a pedestrian crossing of the tracks at this location. In addition, a pedestrian facility would need to be created along S. Mill Street to connect this crossing location with E. German and E. High Streets

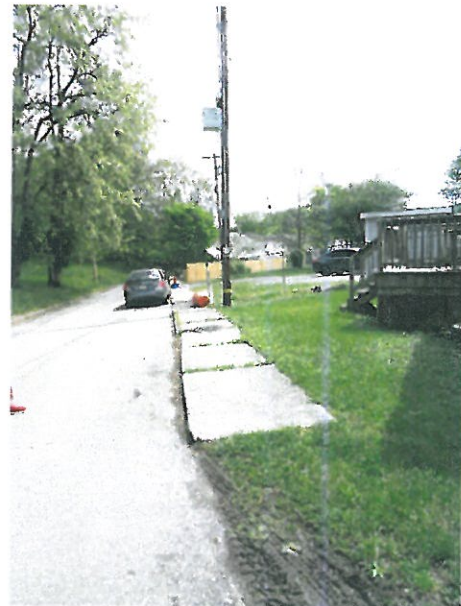
As illustrated here, while the street is gated, there is an opening in the fence which allows pedestrian access. Based on the “goat path” visible in the grass, it appears that this route is regularly used by pedestrians. Thus, it would be desirable to create a formal connection to University Drive.

Currently, the sidewalk on the south side of W. High ends prior to the termination of the street. This would be the starting point for any connection. The connection would need to meet ADA criteria, i.e., smooth, hard surface, desired minimum width of 5 feet, no more than 2% cross slope and maximum grade of 5%.

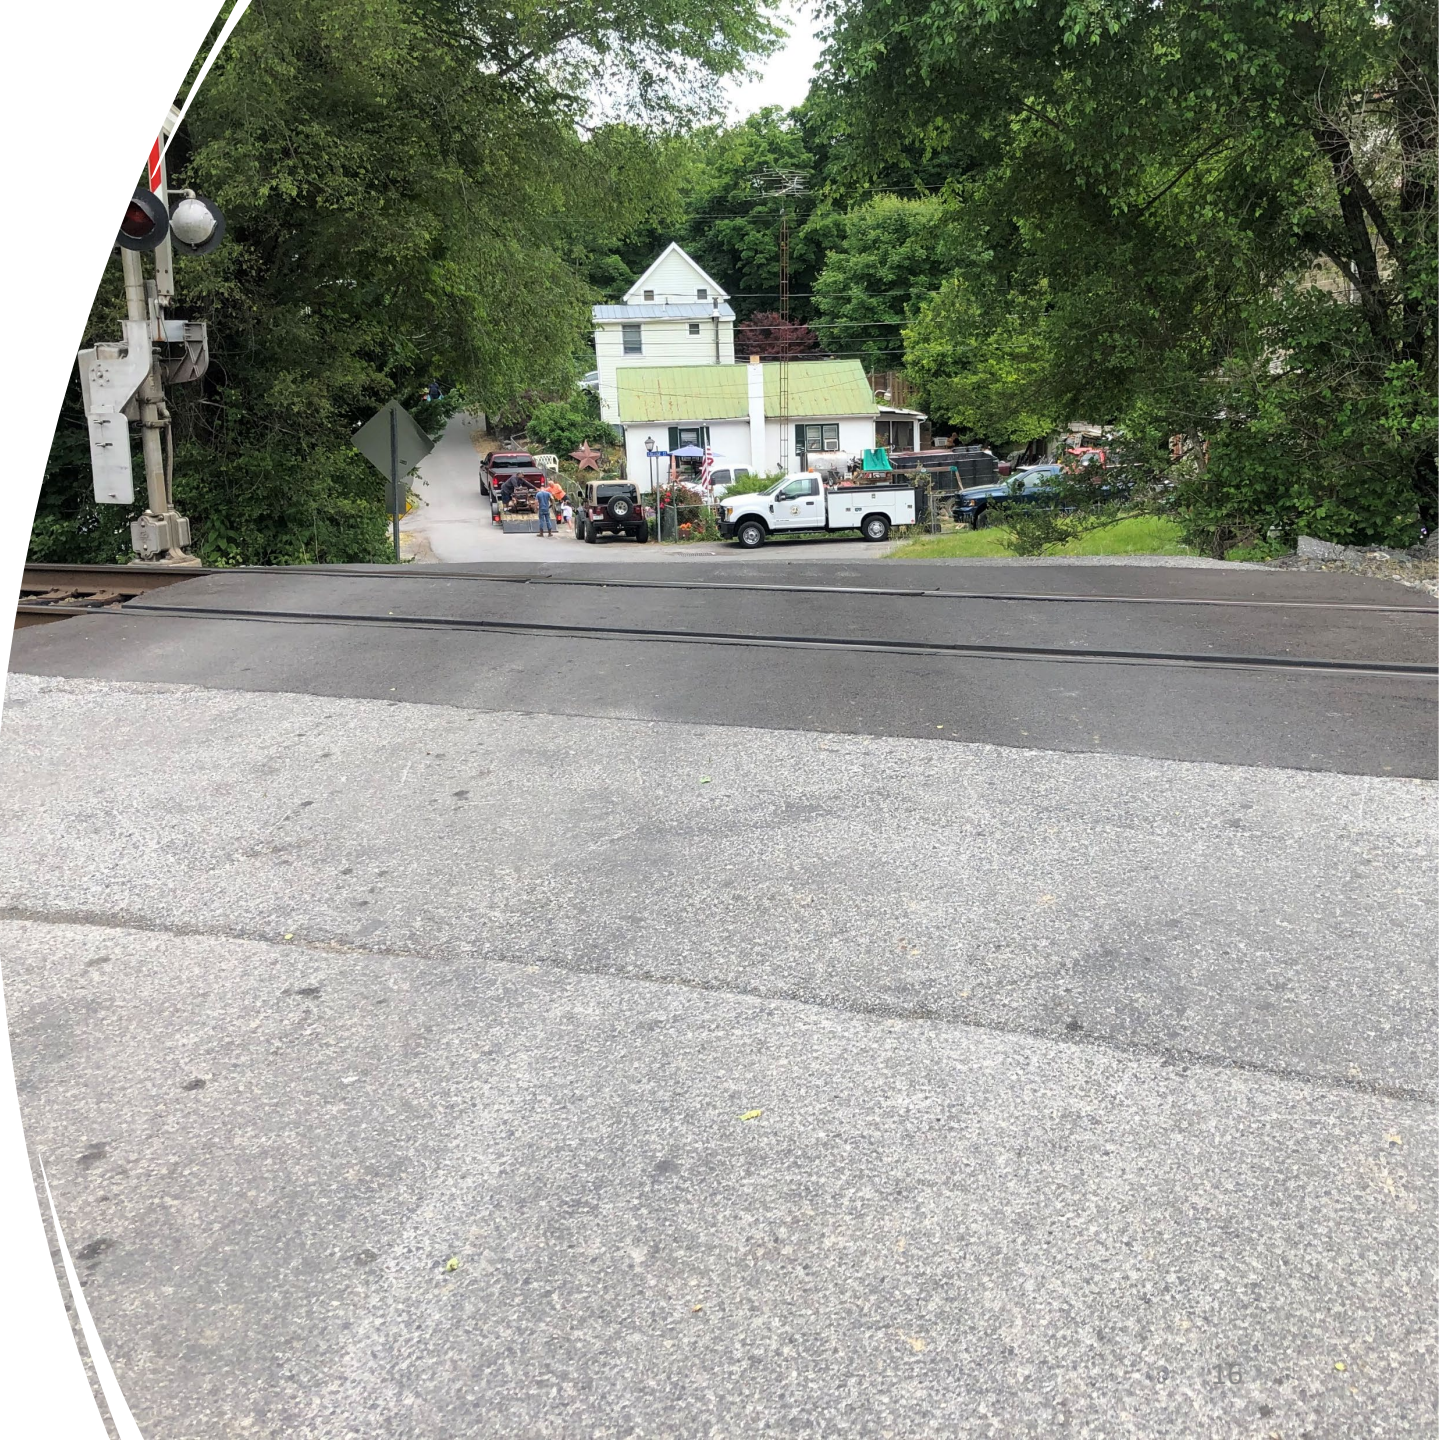
Railroad Crossing at High Street

- Road crossing in good shape
- No sidewalks here

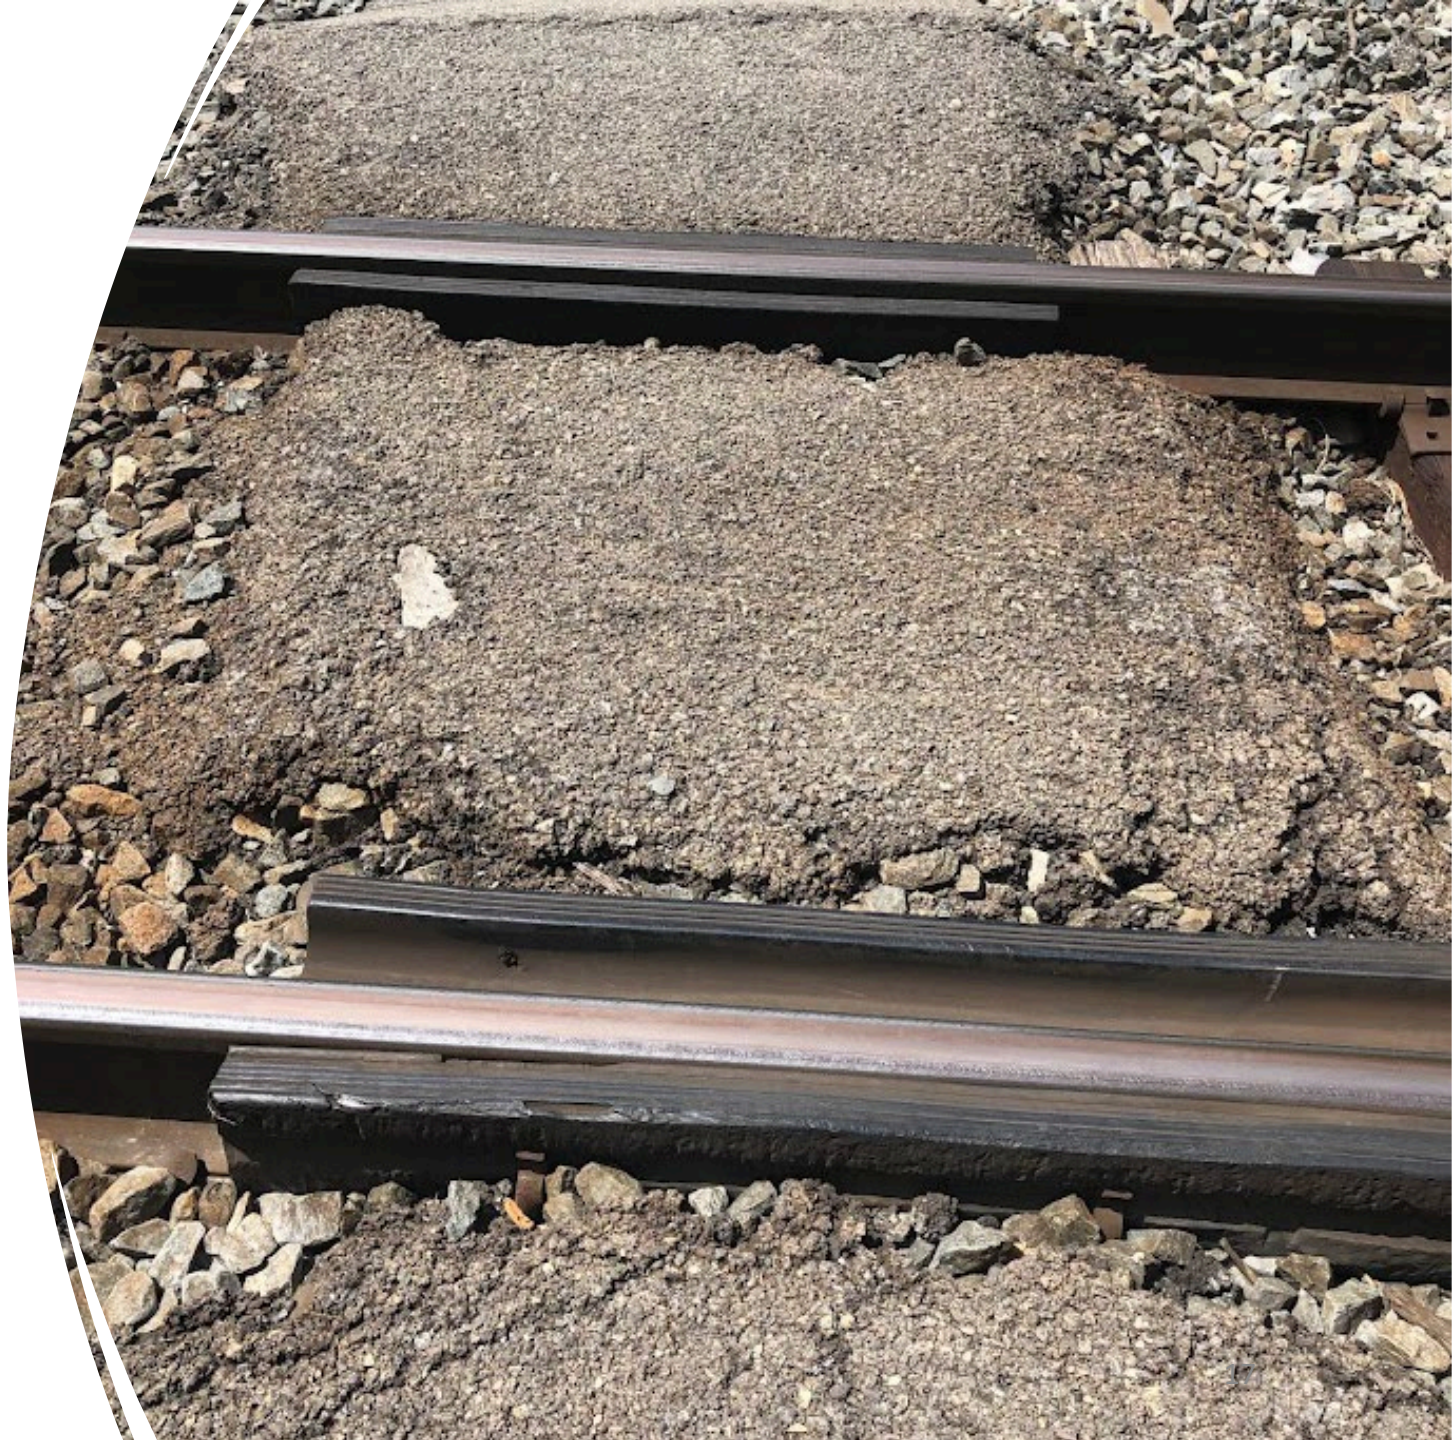
Railroad Crossing at East German Street

- Pedestrian railroad crossing on railway station side
- Difficult to walk across
- To call railroad to see if they can improve the crossing
- On the other side , the crossing is steep and is also difficult to cross
- May need help from town

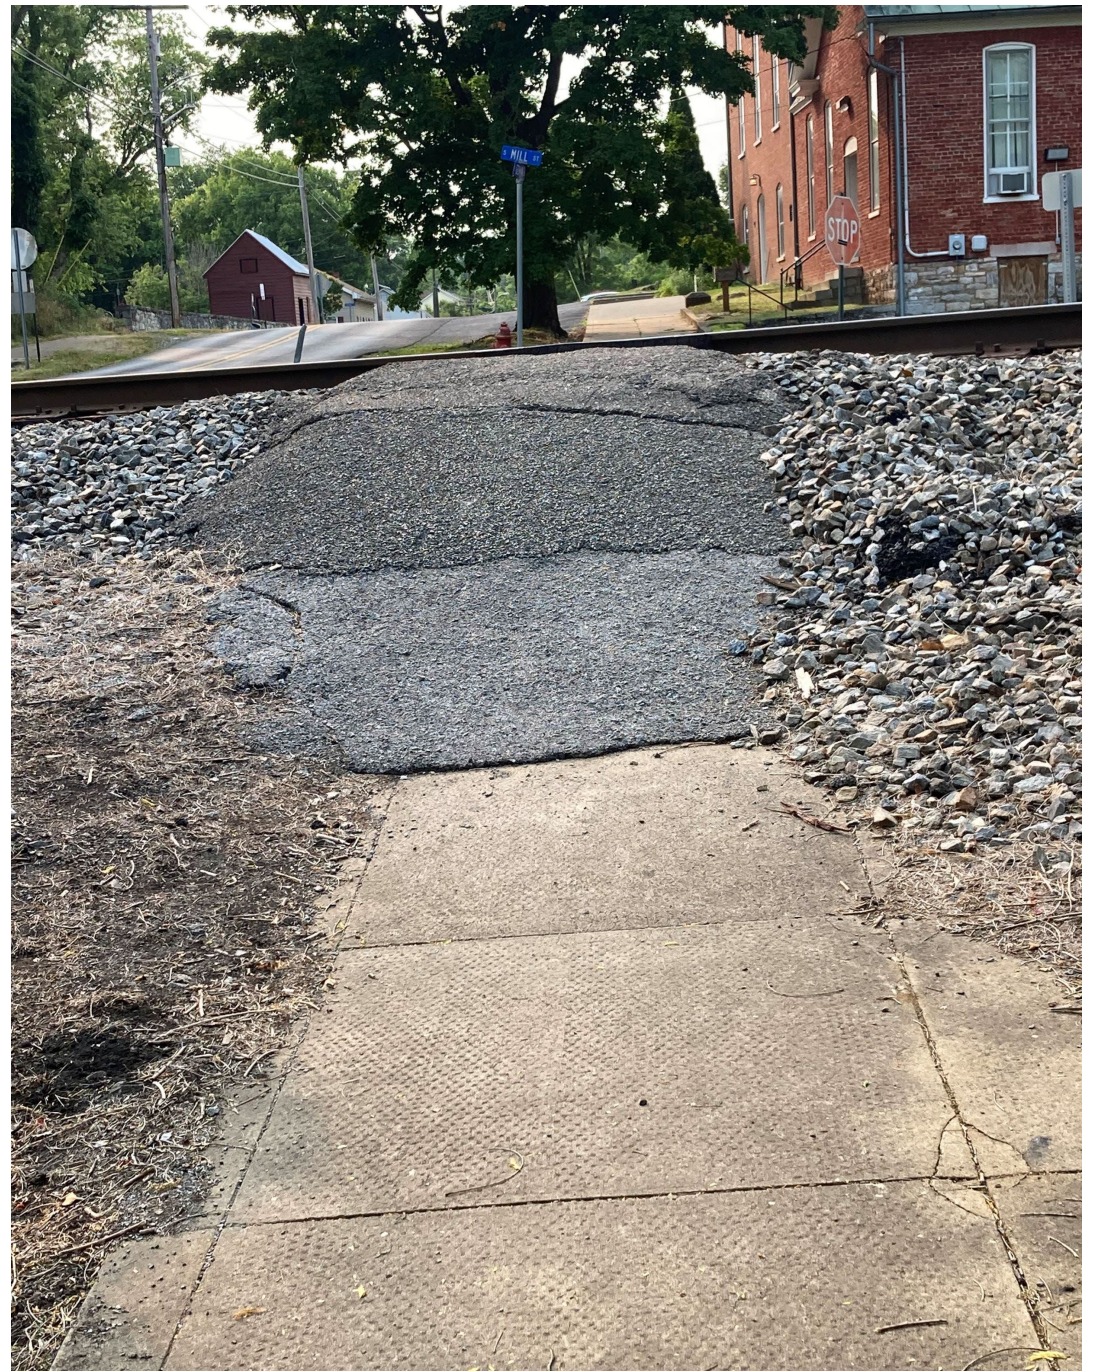
Railroad Crossing at East German Street

- Pedestrian railroad crossing on Tommy's Pizza side
- Difficult to walk down especially in the winter
- To call railroad to see if they can improve the crossing
- May need help from town

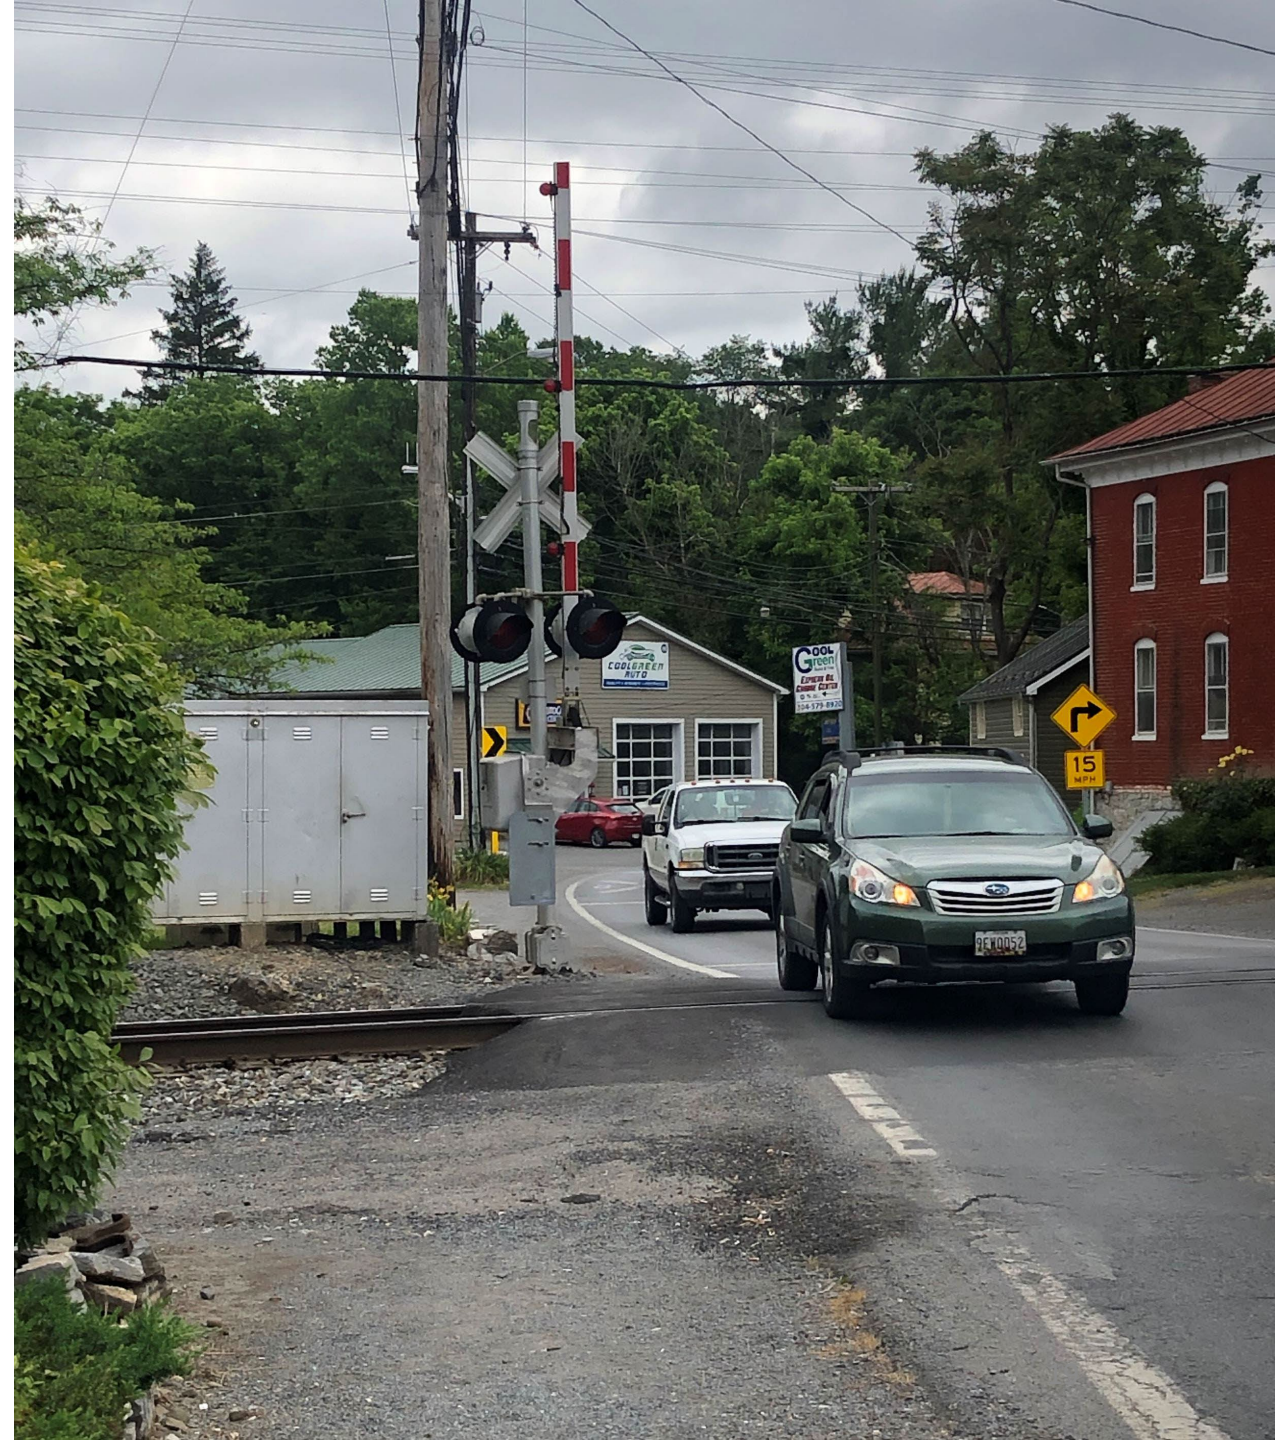
Railroad Crossing at Washington Street

- Railroad crossing near O'Hurley's is in reasonable shape
- Only real concern is that there is little room to walk safely
