Special Public Works Committee Meeting
Wednesday, August 30, 2023
1:00 p.m.
Town Hall

THOUGHTS FROM ADA WALKABOUT TOWN OF SHEPHERDSTOWN JEFFERSON COUNTY, WEST VIRGINIA

TECHNICAL ASSISTANCE REPORT

Sidewalk Survey 2023

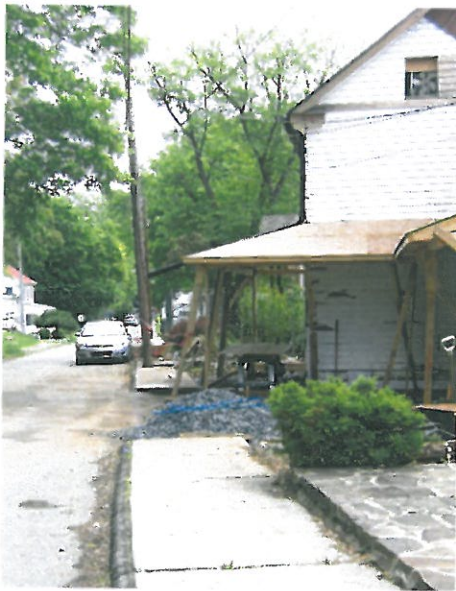
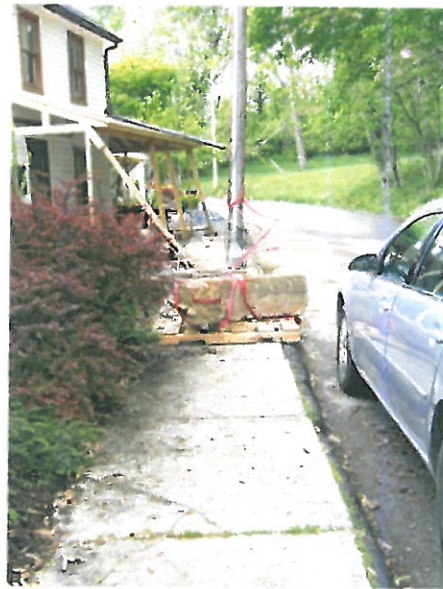
While these activities are temporary, they can and do block pedestrian travel paths and create safety issues for all pedestrians. PROWAG and the *Manual on Uniform Traffic Control Devices* require that sidewalk temporary traffic control be detectable and accessible

It is important that property owners, public works crews, contractors and utilities be advised of these requirements. Permits should be required when a sidewalk is blocked, even temporarily. The provisions of the permit should require that a detectable and accessible pedestrian route be maintained while the sidewalk is closed.

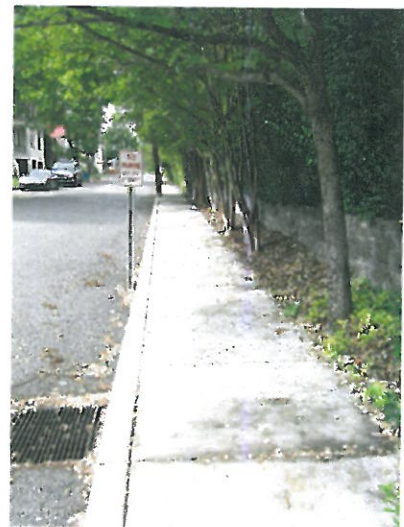
It appeared that sidewalks along N. Mill Street and E. High Street had recently been reconstructed. A section of the sidewalk along N. Mill St. is shown here. However, where the new sidewalk sections intersect in the southwest corner of the intersection, no detectable warnings were installed on N. Mill or on E. High. This corner should be high priority in terms of detectable warning installation. In addition, the requirement for detectable warning surface installation at curb ramps should be part of the sidewalk reconstruction specifications provide to property owners.

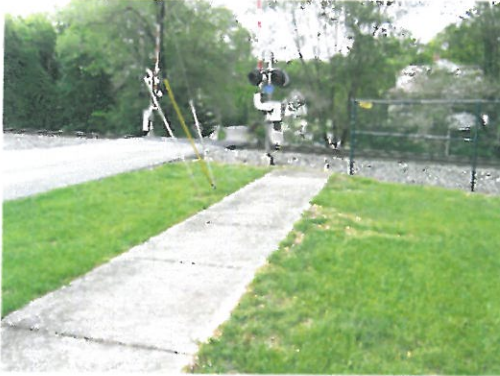
As shown here, due to the gradients involved, the crossing condition is no better on the north side of E. German Street. While not desirable from a safety standpoint, the best route over the crossing for an individual in a wheelchair would be to use the street.

Thus, the E. German Street grade crossing presents a real challenge for all pedestrians. To create an accessible route up to the tracks on the west side, also presents an engineering challenge. Such a route would require a switchback arrangement that may or may not be possible depending on right-of-way availability and the cooperation of Norfolk Southern. Other options for connecting the east side of Town with that west of the tracks should be explored.

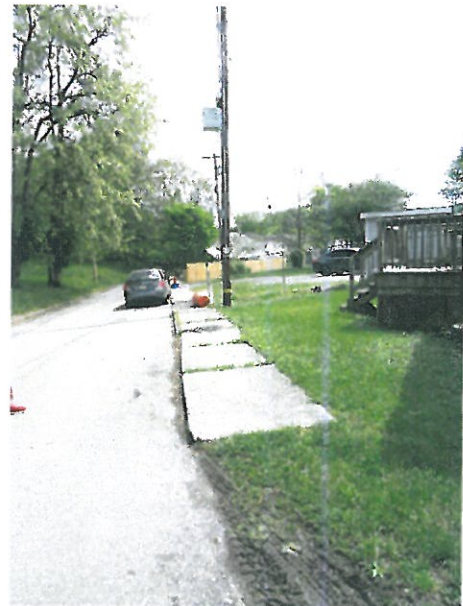
As illustrated here, while the street is gated, there is an opening in the fence which allows pedestrian access. Based on the “goat path” visible in the grass, it appears that this route is regularly used by pedestrians. Thus, it would be desirable to create a formal connection to University Drive.

Currently, the sidewalk on the south side of W. High ends prior to the termination of the street. This would be the starting point for any connection. The connection would need to meet ADA criteria, i.e., smooth, hard surface, desired minimum width of 5 feet, no more than 2% cross slope and maximum grade of 5%.
